A.4 SOLAR FARM ‘FREQUENTLY ASKED QUESTIONS’

Walla Walla Solar Farm

FREQUENTLY ASKED QUESTIONS

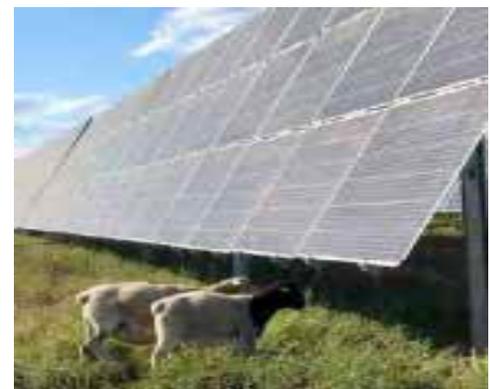
Sheep grazing at FRV’s operational Lilyvale Solar Farm.

A FRV have examined operational solar farms and have found that the grass growth is maintained underneath the panels thus allowing the continued grazing of the land within a solar farm.

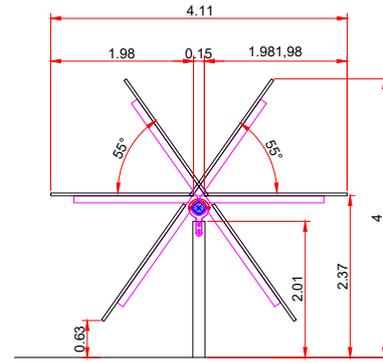
Indicative profile view of a row of panels on tracking mount system. At night panels will be stowed in the horizontal position. (Dimensions in metres)

heat underneath. These solar panels are thin (< 4cm) so they do not retain heat over the long term. During the daytime, panels track the sun, moving through the positions shown right, from sunrise to sunset.

Spacing between rows will be between 8-14 metres. The tracking mount system will be programmed to store panels in stow position (i.e. facing up to the sky, approx. horizontal to the ground) at night for cooling. In the stow position panels are approx. 2 metres off the ground.

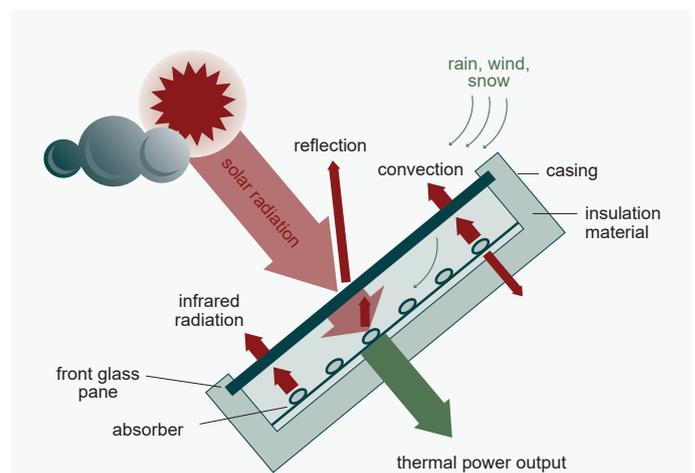
Basic structure and main components of the solar panel 'sun collector'. From Solar Thermal Technology Update (Matthias et al: 2010)

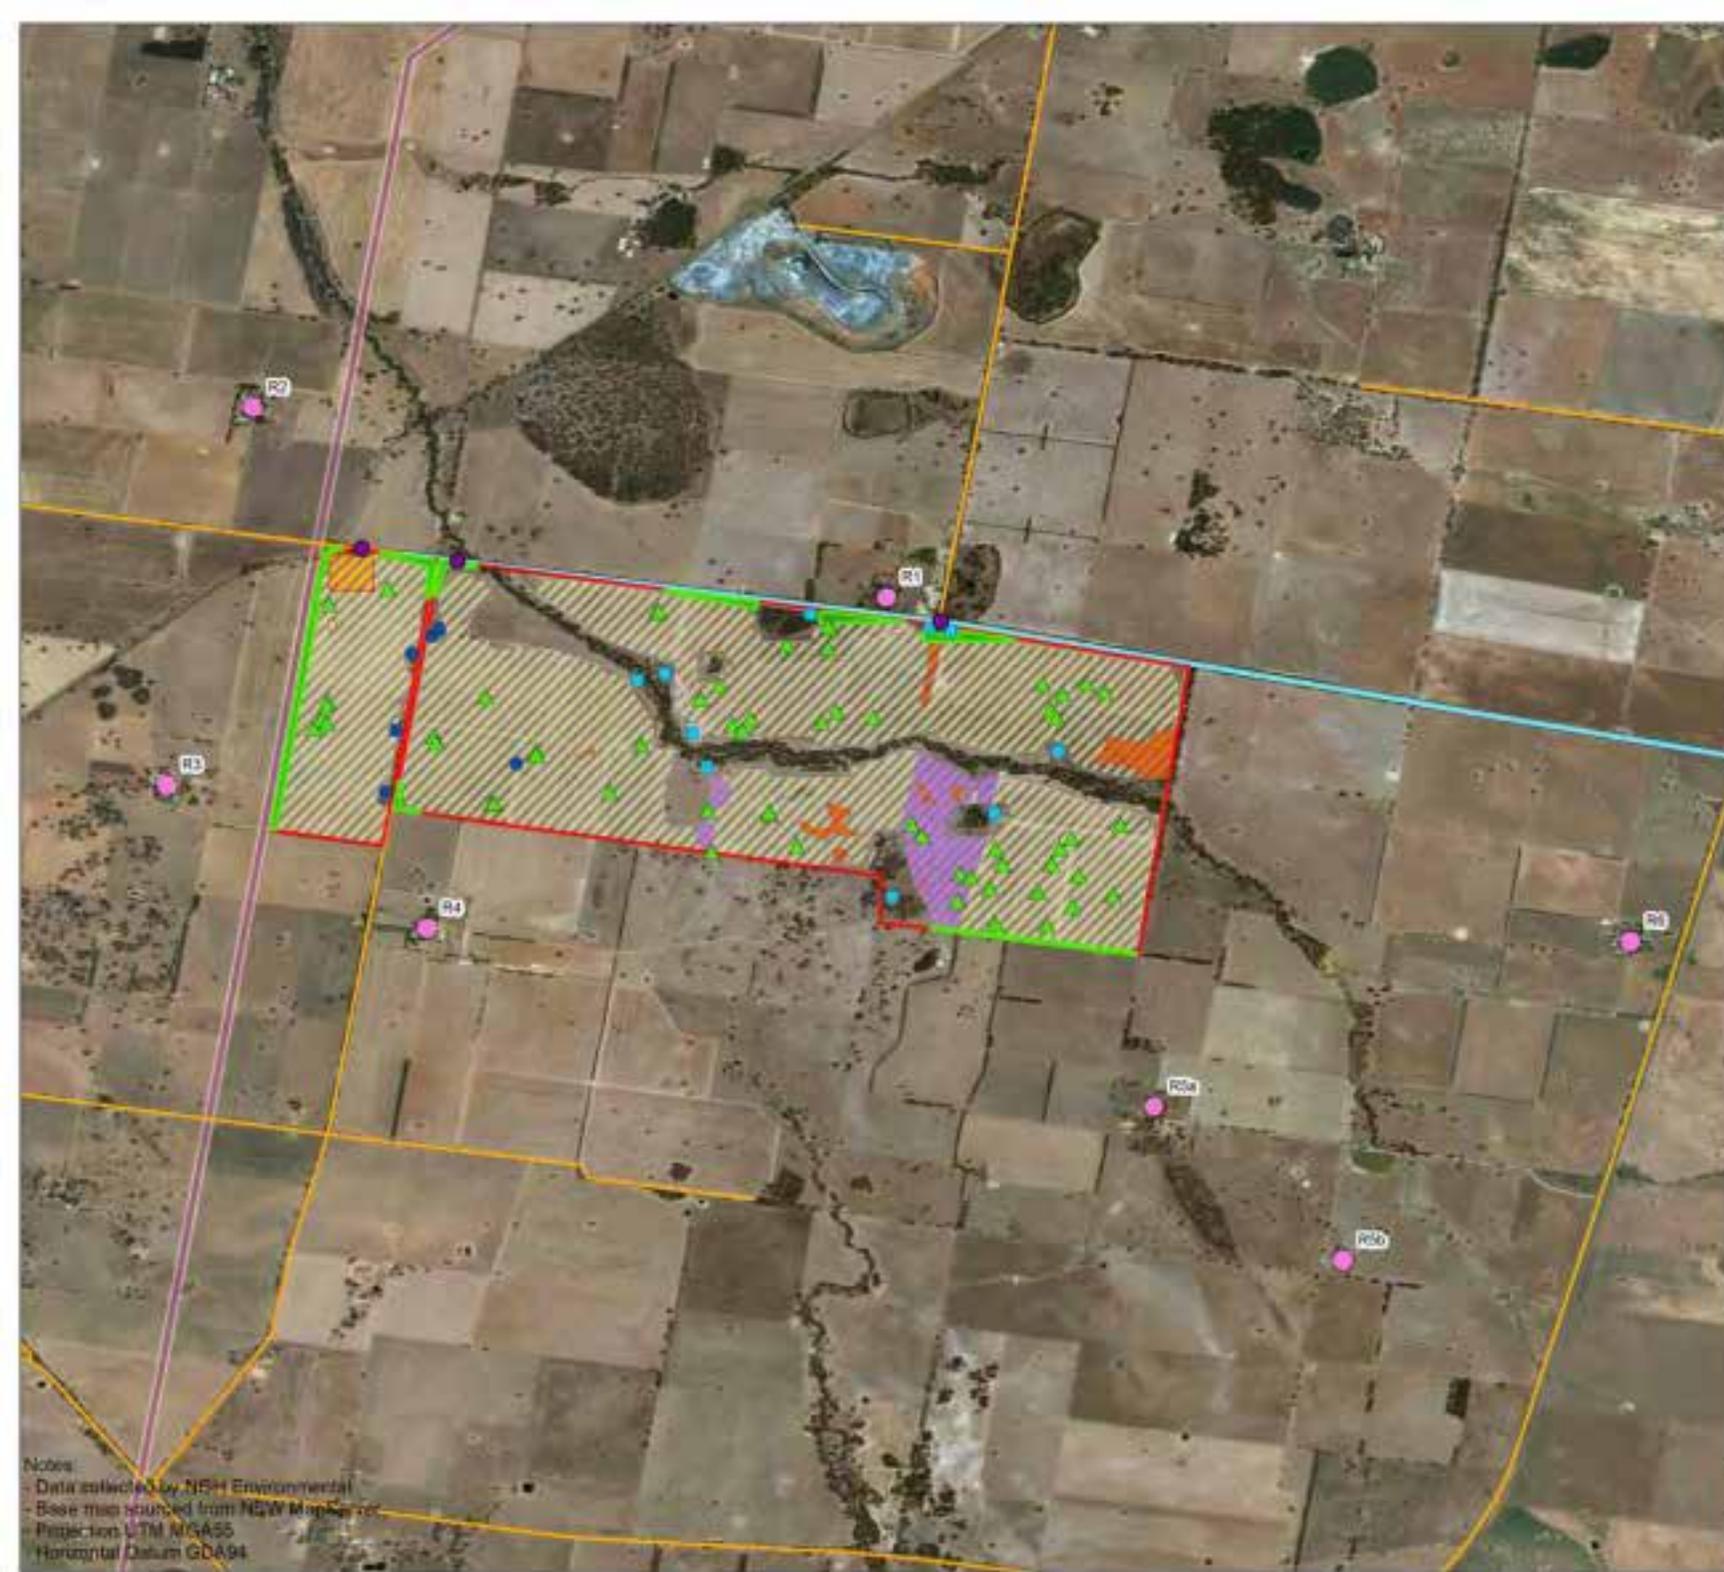
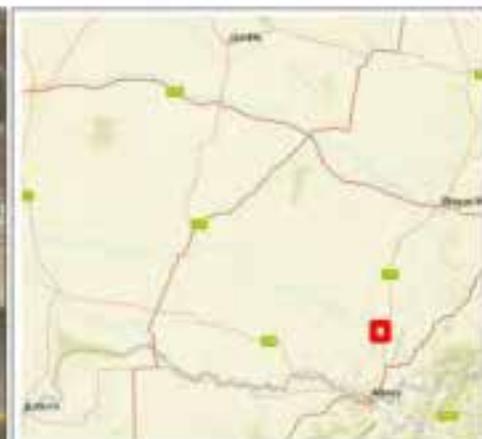
- Dam to be removed
 - Dam to be repaired
 - ▲ Protected Trees Impacted
 - Adjoining Landholders
 - Access Point
 - Development Site
 - Impervious Development Footprint
 - Proposed Vegetation Screening
 - Clearland
 - Slow Transmission Line Element
 - TransGrid 220 kV Transmission Line
 - Roads
 - Topogrid Tracks
- Native Vegetation Impacted**
- PCT 201 Shady's Red Gum Yellow Box Woodland
 - PCT 76 Grey Box Woodland
 - PCT 76 Grey Box Woodland - Declared Overland
 - PCT 5 Blue Red Gum Yellow Woodland

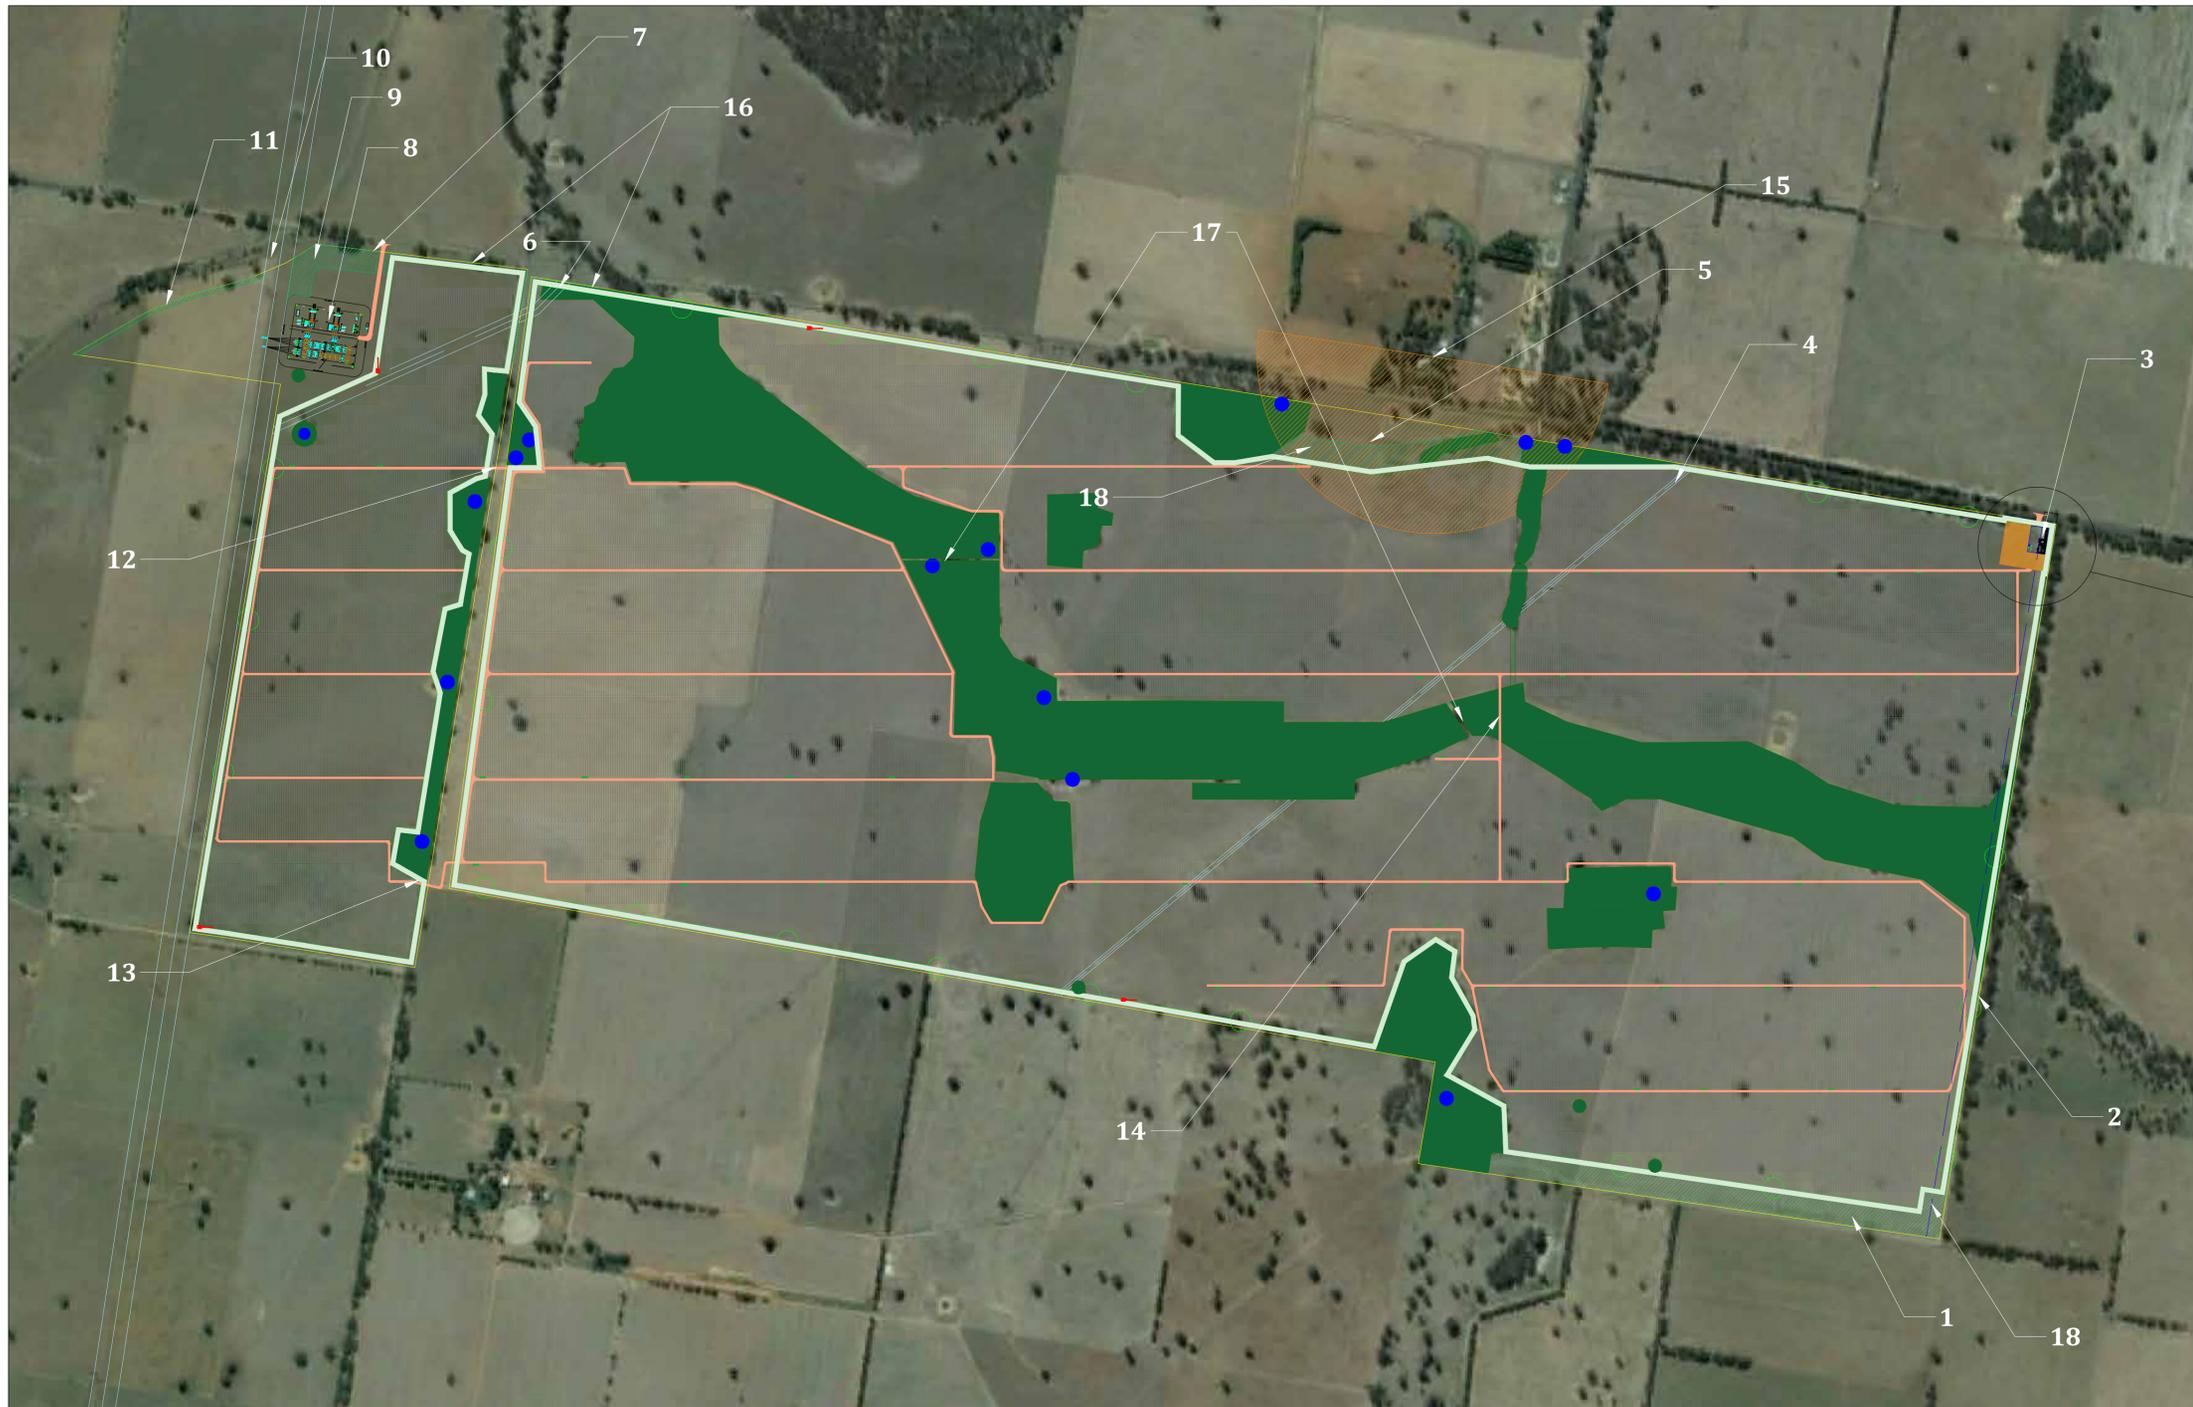
PLANT SUMMARY "WALLA WALLA"		
Total Inverter Power of Plant @50°C:	363.69 MVA	
Total DC Peak Power (STC):	335 MWp	
Area:	Fenced area	Fence length
	546.6 Ha	14,885 m

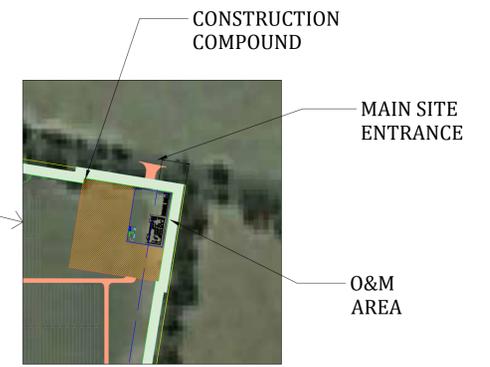
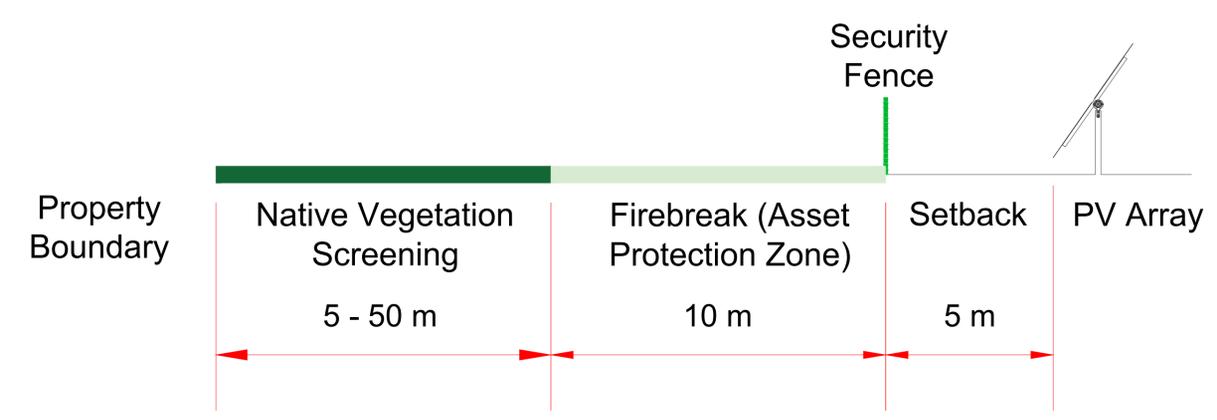
LEGEND	
1.	Southern Vegetation Buffer - 50 m width
2.	Eastern Vegetaytion Buffer - 5 m width
3.	Construction Compound, O&M Area & Main Site Entrance
4.	Water Pipeline - 10 m easement
5.	Northern Vegetation Buffer - 50 m width
6.	Gas Pipeline - 24 m easement
7.	Transgrid Access
8.	Transgrid Substation
9.	Northwest Vegetation Buffer I - 50 m width
10.	Overhead 330kV Transmission Line - 60 m easement
11.	Northwest Vegetation Buffer II - 10 m width
12.	Access / Crossing - Schneiders' Road - North
13.	Access / Crossing - Schneiders' Road - South
14.	Creek Crossing Point - 35°44'52"S - 146°58'32"E
15.	Inverter Exclusion Zone - 400 m radius
16.	Northwest Vegetation Buffer III - 5 m width
17.	Creek Cable Crossing
18.	Distance to the Eastern Boundary - 30 m

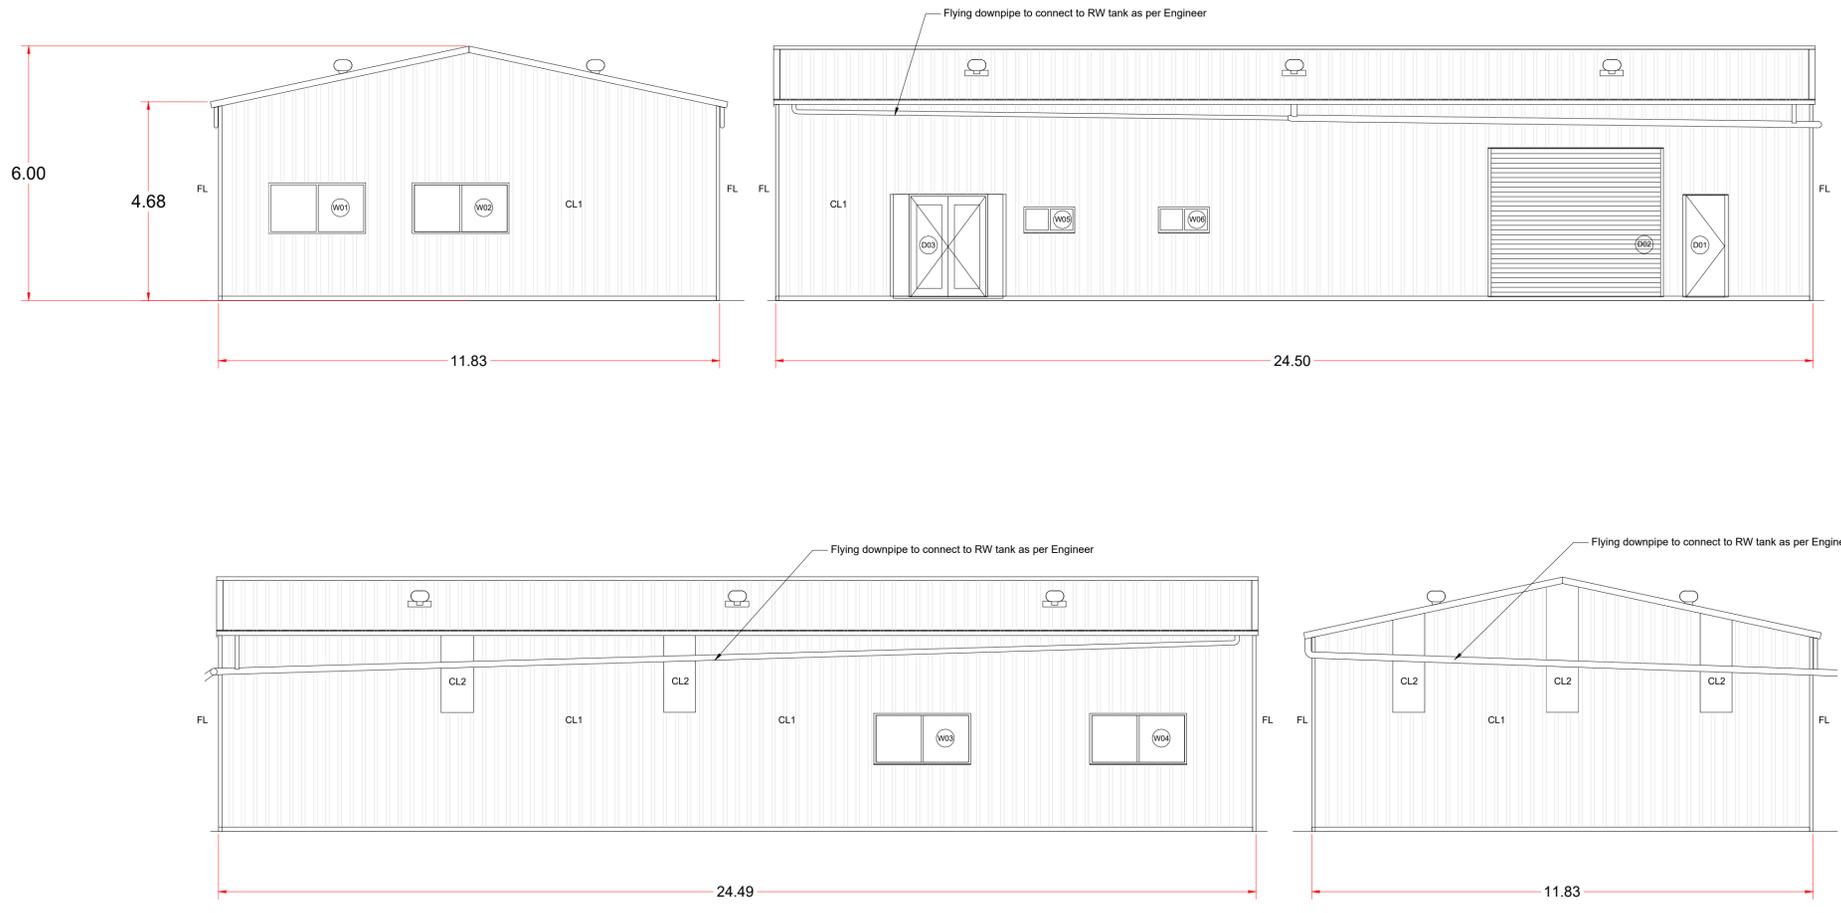
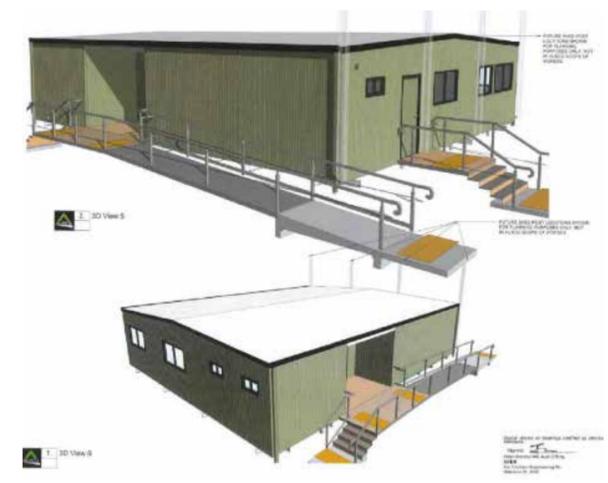
Example of control building with similar characteristics

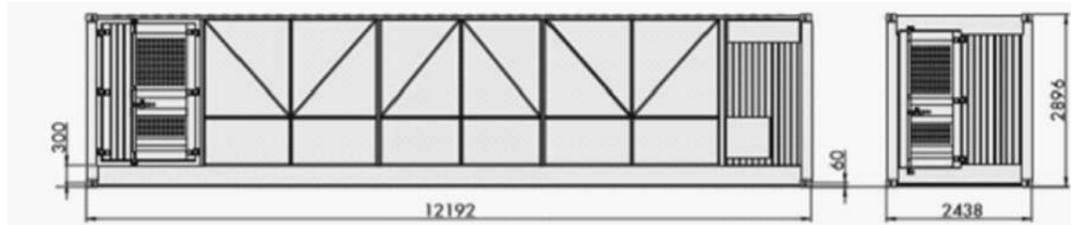
Figure 29: Dimensions of the MV Power Station (in mm)

Width	Height	Depth	Weight
12192 mm	2896 mm	2438 mm	< 26.5 t

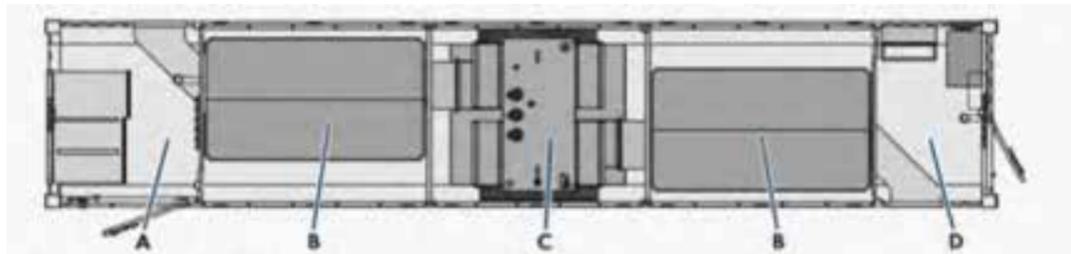
Figure 2: Design of the MV Power Station

Position	Designation	Explanation
A	Medium-voltage compartment	MV switchgear The MV switchgear connects and disconnects the MV transformer to and from the medium-voltage grid.
B	Sunny Central	The Sunny Central is a PV inverter that converts the direct current generated in the PV arrays into grid-compliant alternating current.
C	MV transformer	The MV transformer converts the inverter output voltage to the voltage level of the medium-voltage grid.
D	Low-voltage compartment	<p>Station subdistribution The station subdistribution contains fuse and switching elements for the supply voltage.</p> <p>MV Power Station low-voltage transformer The low-voltage transformer provides the supply voltage for the MV Power Station and its components.</p> <p>Customer installation location The MV Power Station customer installation location is reserved for customer-supplied devices.</p>

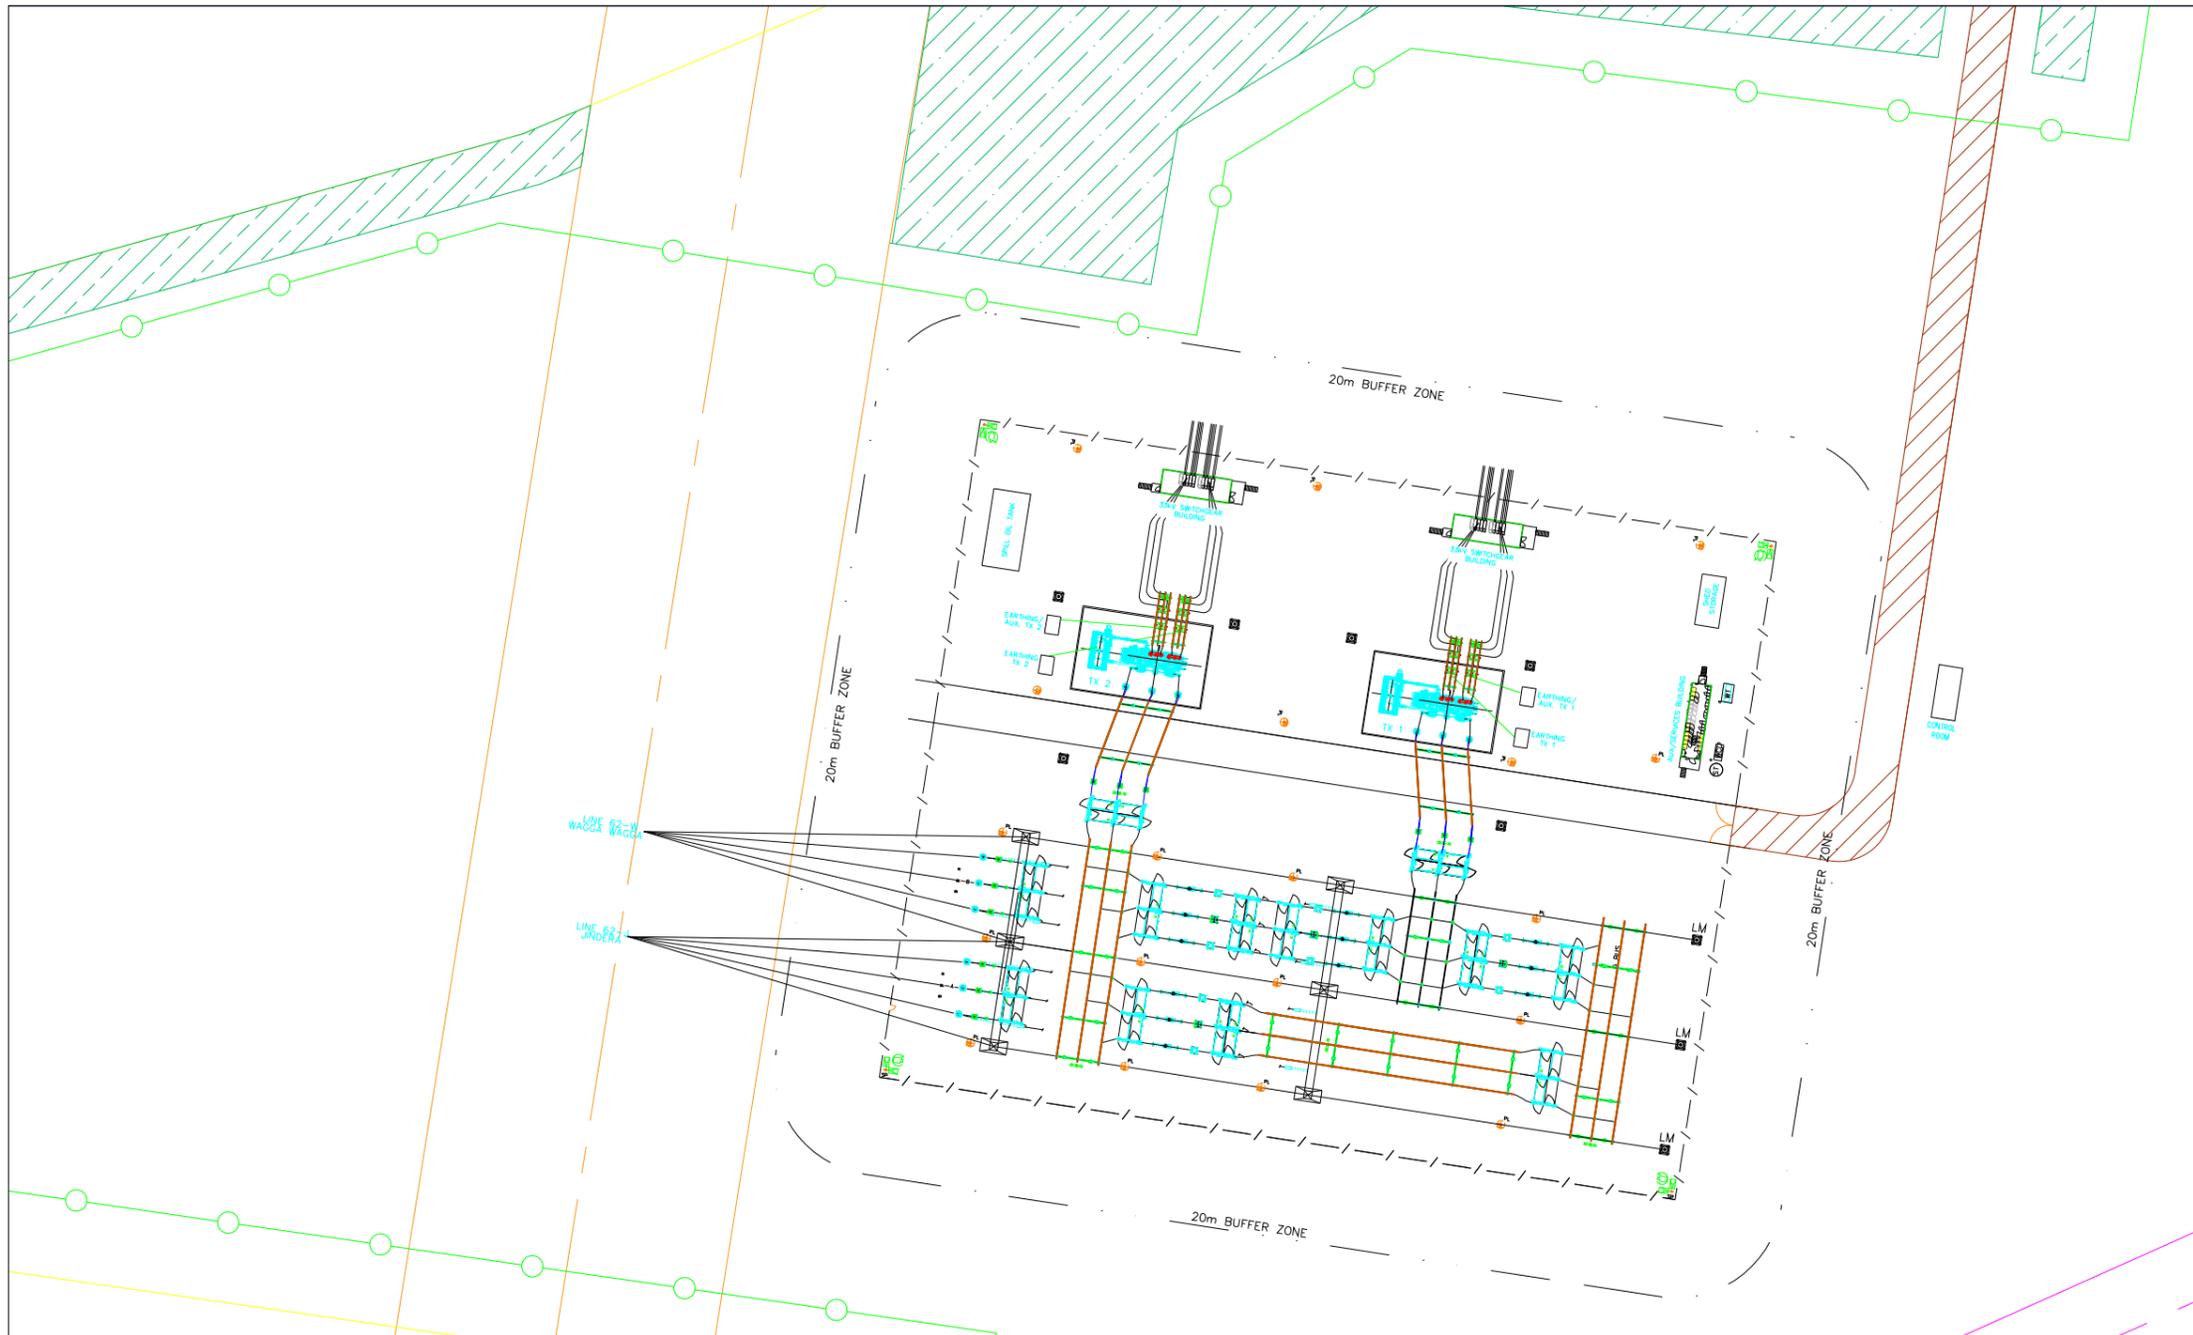
Typical Lighting Mast

- Lightning: 20 m + 2.5 m lightning rod
- 330 kV Line Gantry: 21 m to 25 m + 2.5 m lightning rod
- Auxiliary Services Building: 5.5 m + 2.5 m lightning rod
- 33 kV Switchroom: 5.5 m + 2.5 m lightning rod

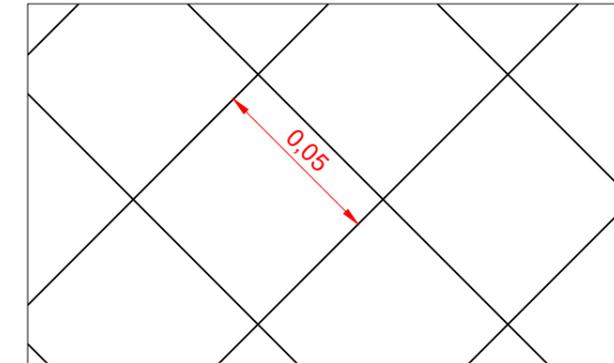
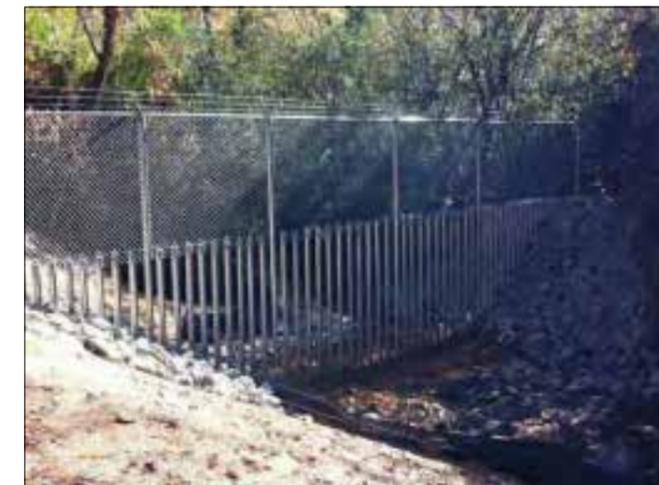
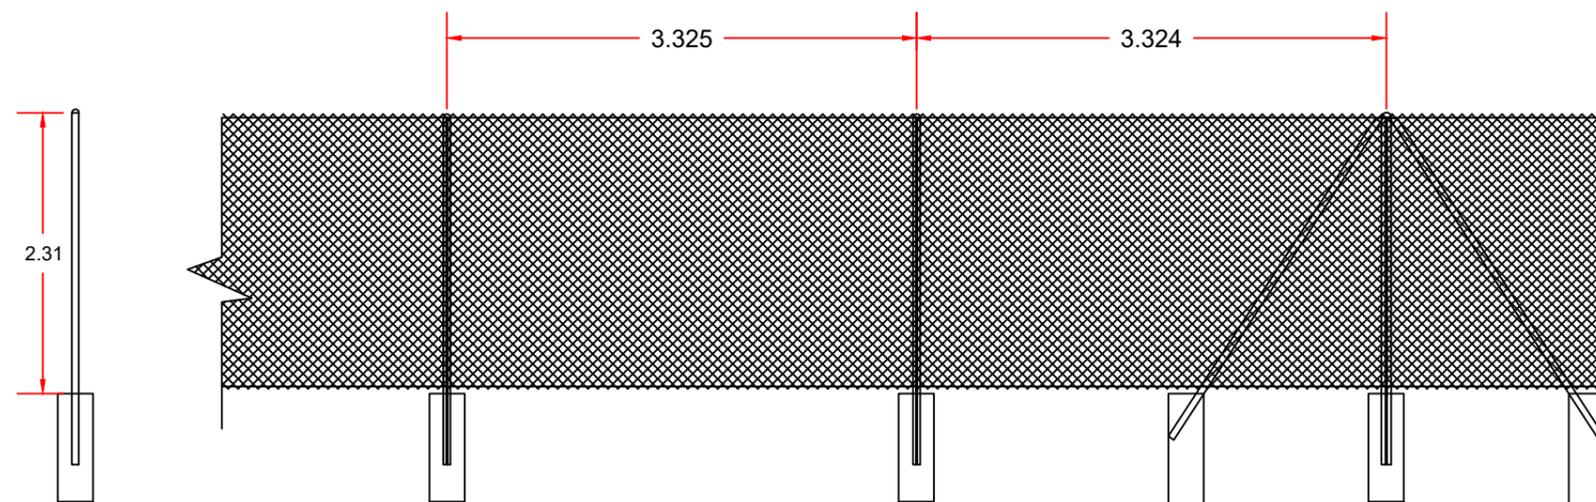
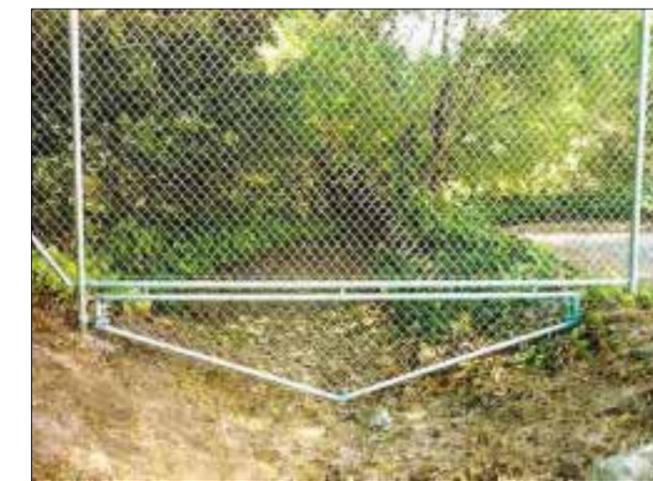
Indicative Fence Flood Gate

- Notes
- Maximum fence mesh height: 2.4m
 - Fence mesh is uncoated galvanized chain wire.

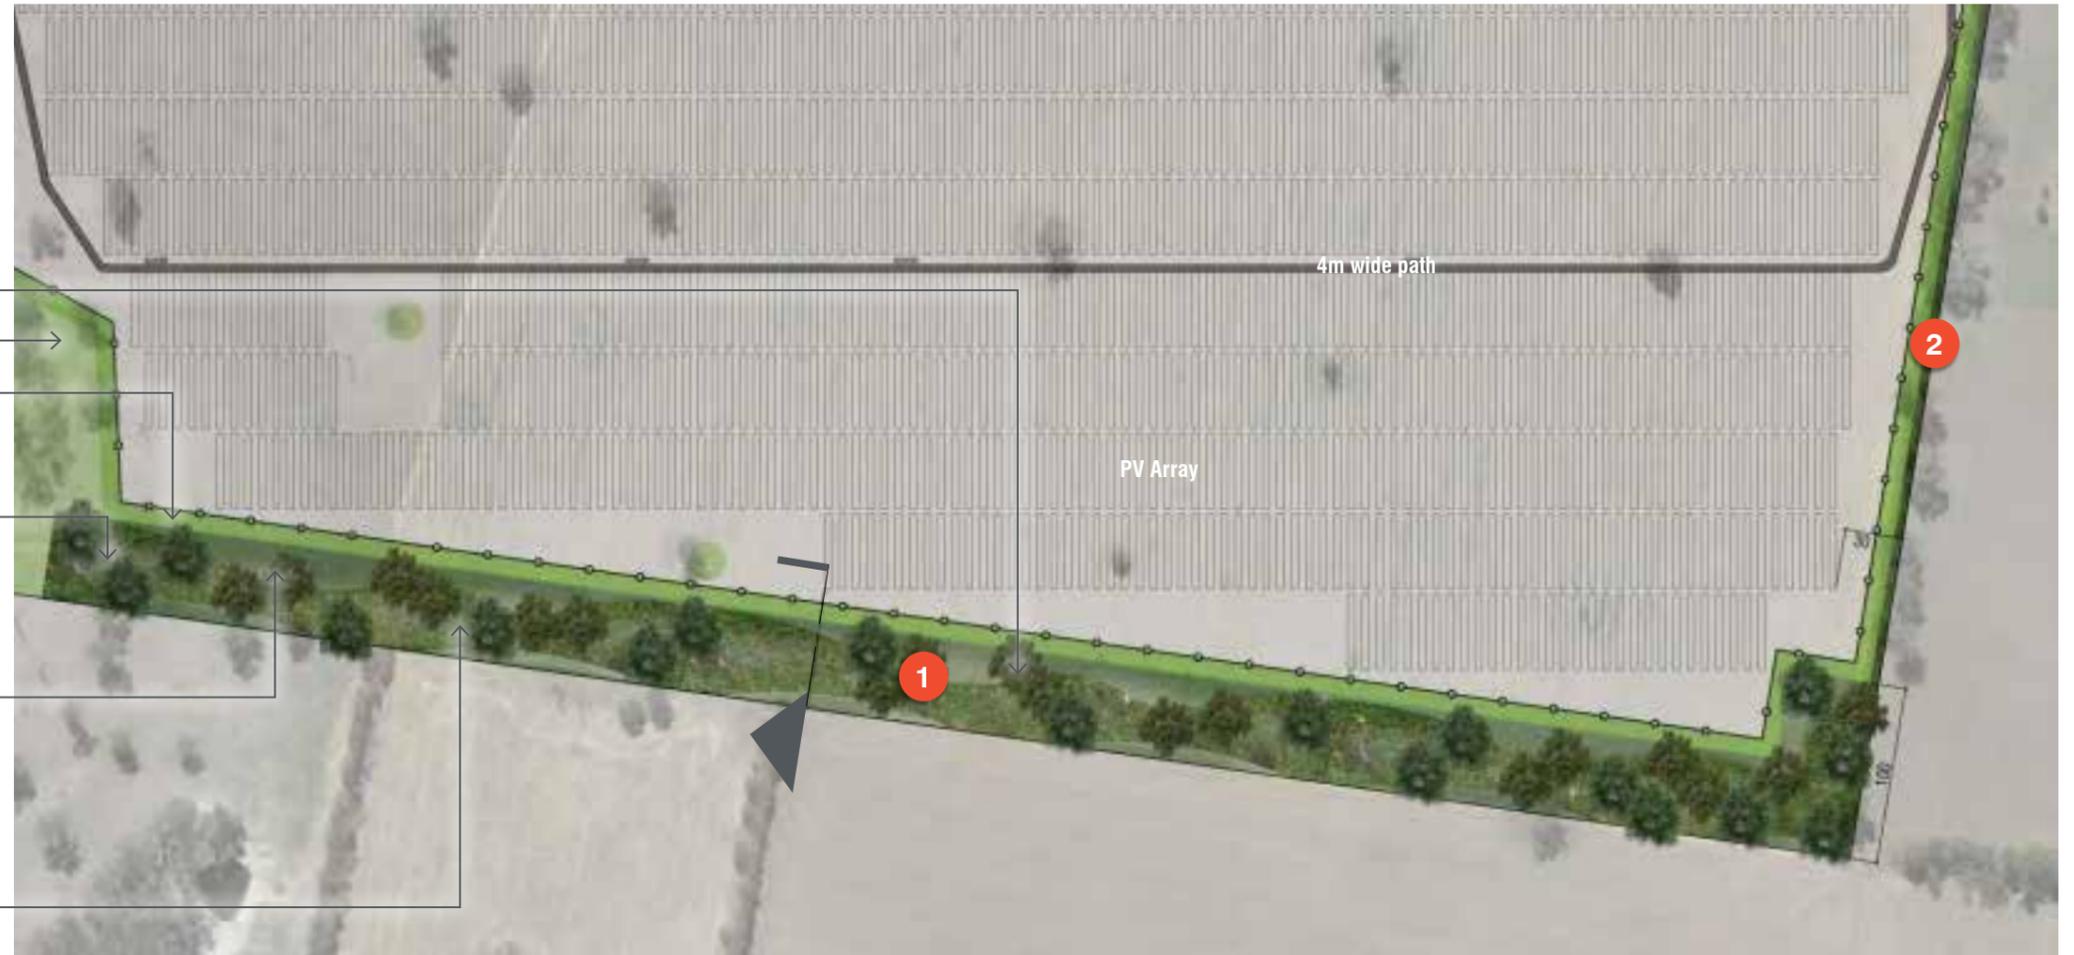
PLAN 1:4000

Medium evergreen trees e.g.
Acacia dealbata (Silver Wattle)
Acacia implexa (Lightwood)
Allocasuarina leuhmannii (Bulloak)
Allocasuarina verticillata (Drooping Sheoak)

Shrubs and groundcovers e.g.
Acacia acinacea (Gold-dust Wattle)
Acacia rubida (Red-stemmed Wattle)
Bursaria spinosa (Sweet Bursaria)
Dodonea viscosa subsp. *angustissima* (Narrow-leaf Hop-bush)

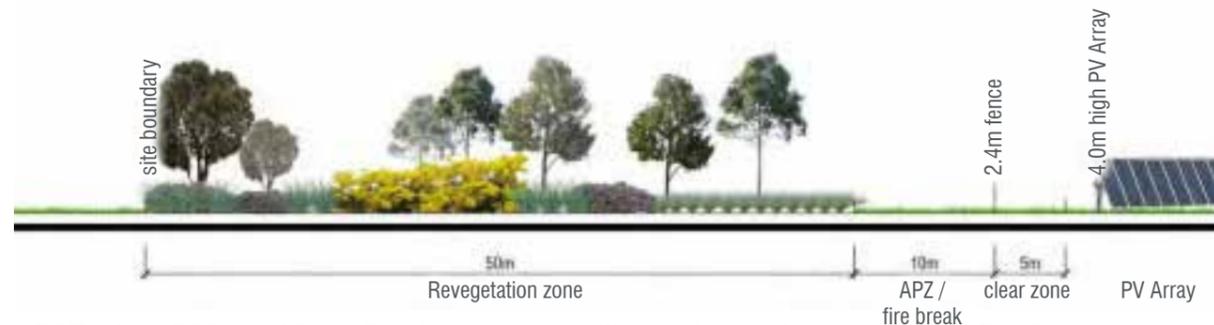
SECTION 1:500 @ A3 Section graphical illustration indicative growth 5 – 8 years

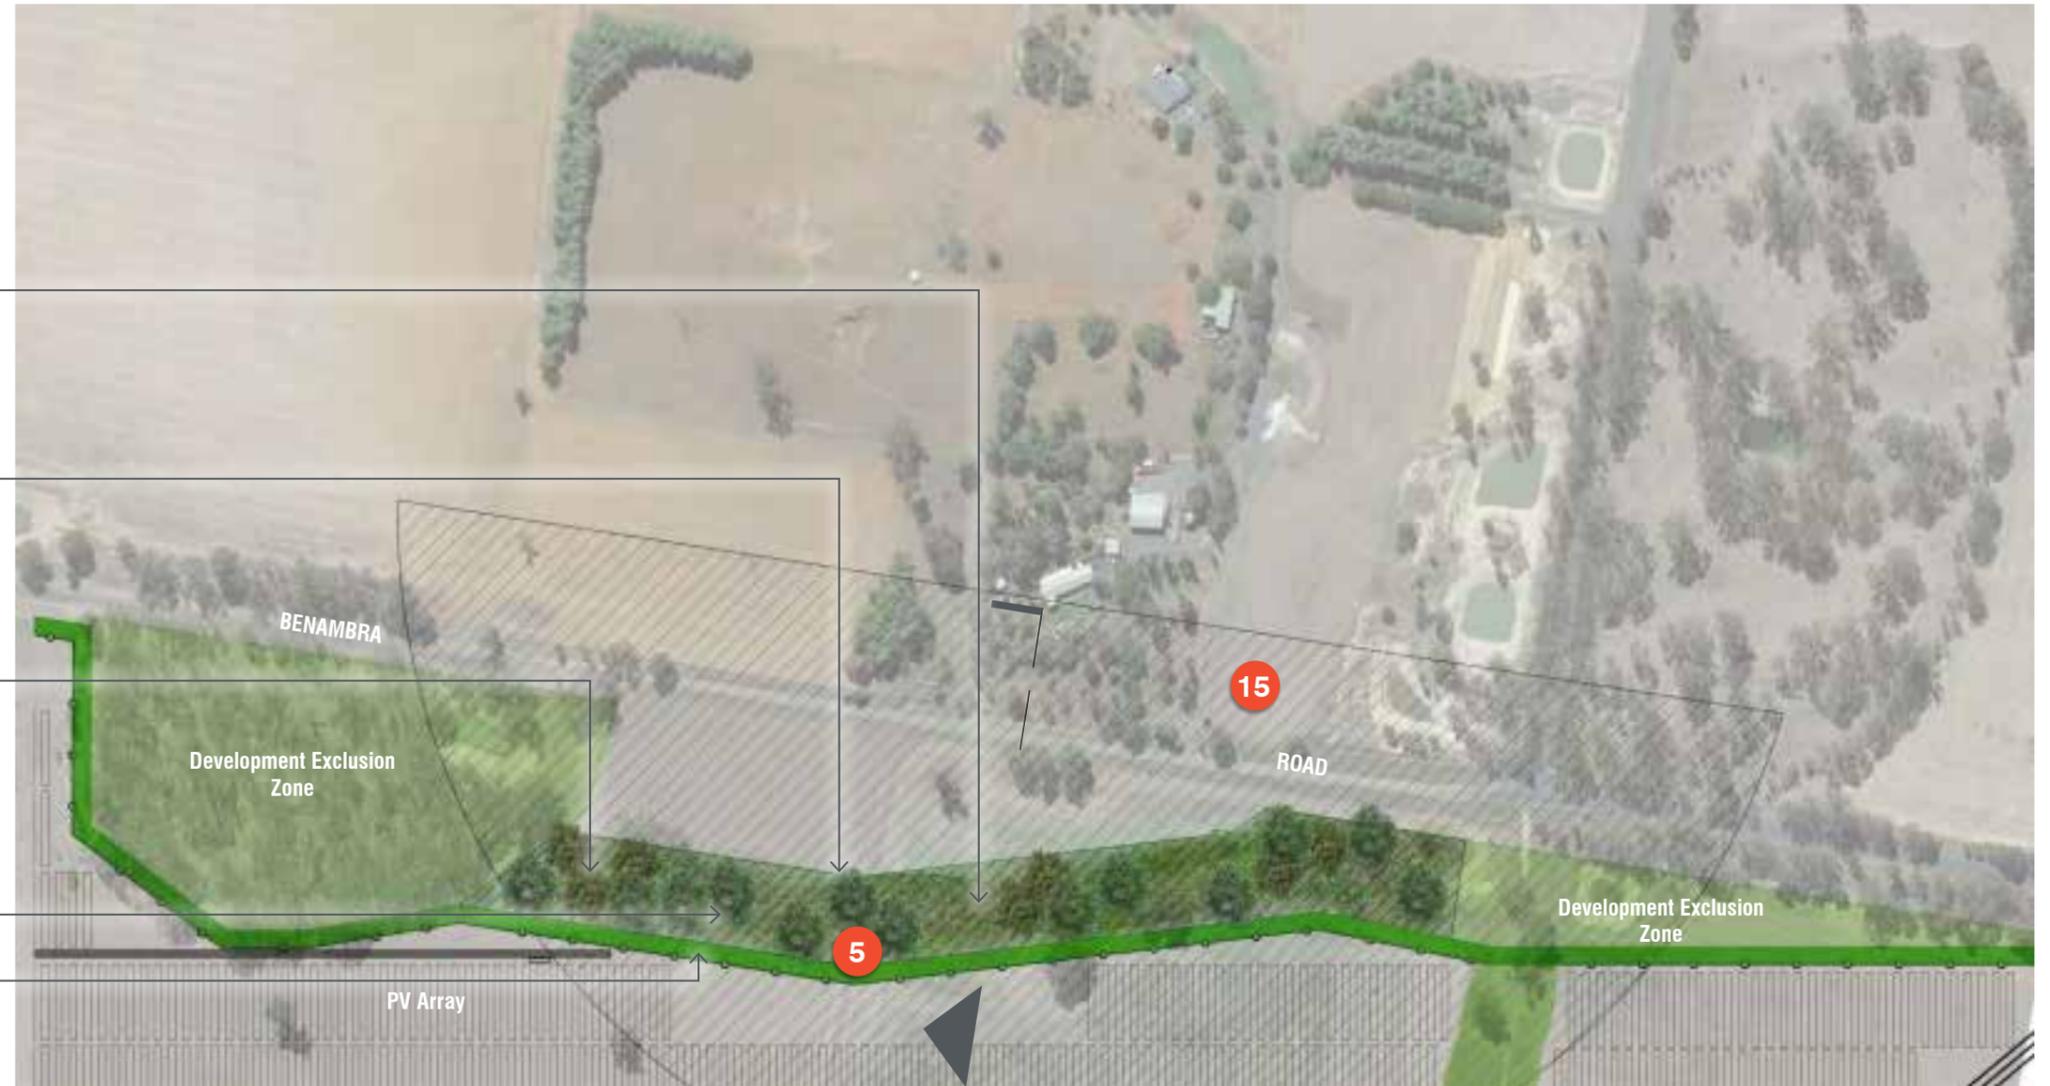
PLAN 1:4000

Asset Protection Zone / Firebreak – 10m wide

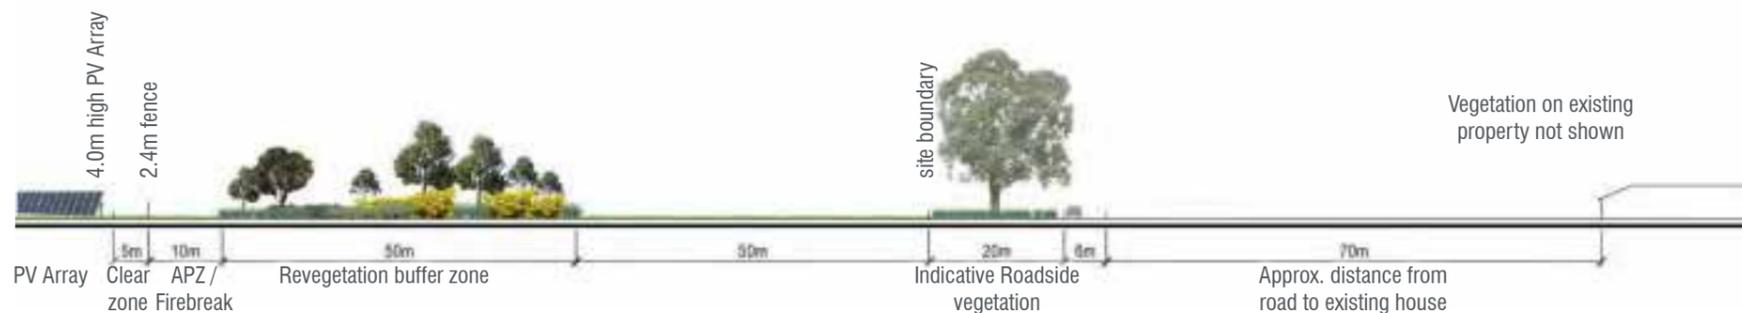
SECTION 1:1000 @ A3

Section graphical illustration indicative growth 5 – 8 years

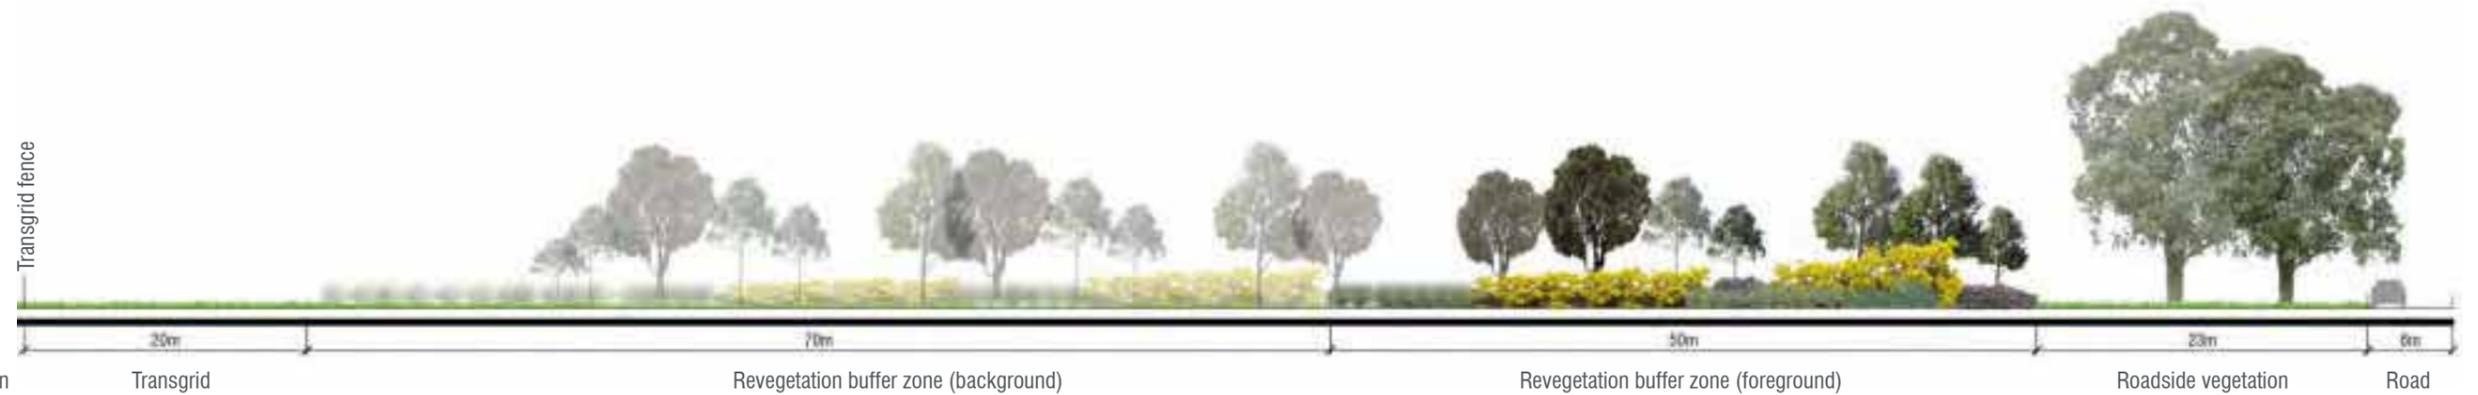
SECTION 1:500 @ A3 Section graphical illustration indicative growth 5 – 8 years

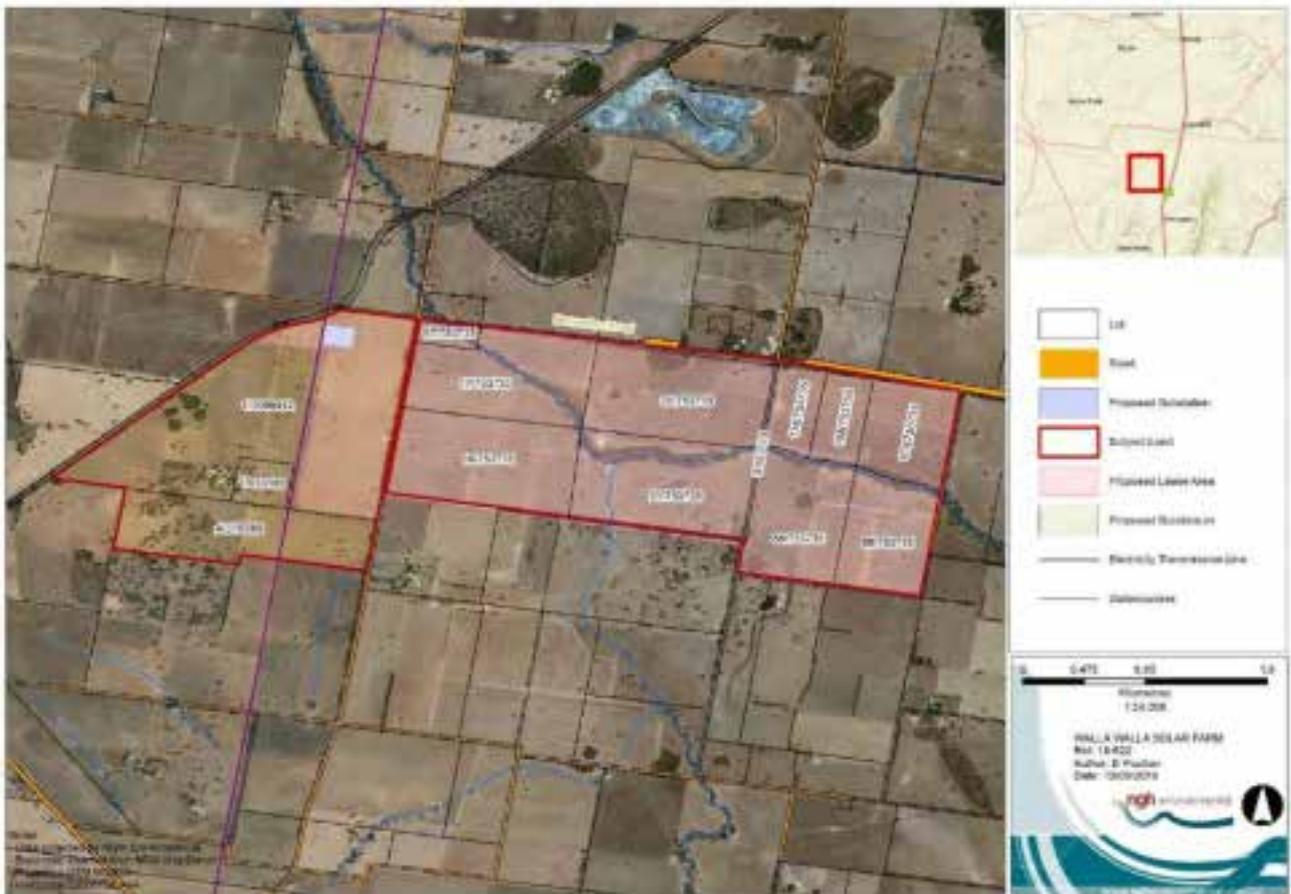
Figure 3 illustrates the existing sites which are approximately 605 hectares collectively and are zoned RU1 Primary Production under the Greater Hume LEP 2012. The current site is located to the north east of Walla Walla and is bounded by Schneiders Road to the west and Benambra Road to the north. The site also has several important environmental features including Back Creek running through the middle of the site, several dams and a number of existing trees scattered across the whole site. The subject land covers a number of lots including:

- Lots 16, 17, 20, 21, 87, 88, 89, 108, 109 118 of DP 753735;
- Lot 3 DP 253113;
- Lot 1 DP 1069452;
- Lot A DP 376389; and
- Lot 1 DP 933189.

Figure 3 Zoomed-in image of proposed site for development featuring lot labels and boundaries (source: NGH)
