A.4 SOLAR FARM ‘FREQUENTLY ASKED QUESTIONS’

Walla Walla Solar Farm

FREQUENTLY ASKED QUESTIONS

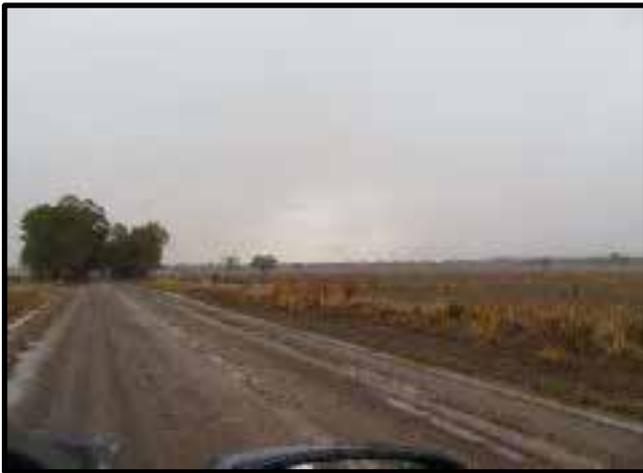
Figure 5 Schneiders Road facing south

- Unsealed single carriageway approximately 7.0 metres in width with one-lane in each direction (i.e. 2 x 3.5m traffic lanes) and no posted speed limits

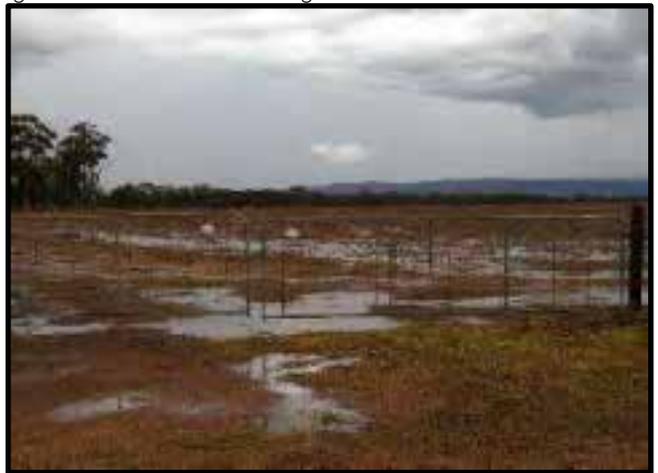
Figure 4 Schneiders Road facing east – proposed crossing point

Schneiders Road is a minor part of the road network surrounding the proposed site and is classified as a local road which is managed by Council (see **Figure 4**). Schneiders Road would not be utilised by construction traffic but crossed at two location points to access from the east to the west of the development and vice versa. Schneiders Road would also provide emergency access during operations (see **Figure 8**). Being a minor local road in the area of Walla Walla, it reflects the following characteristics:

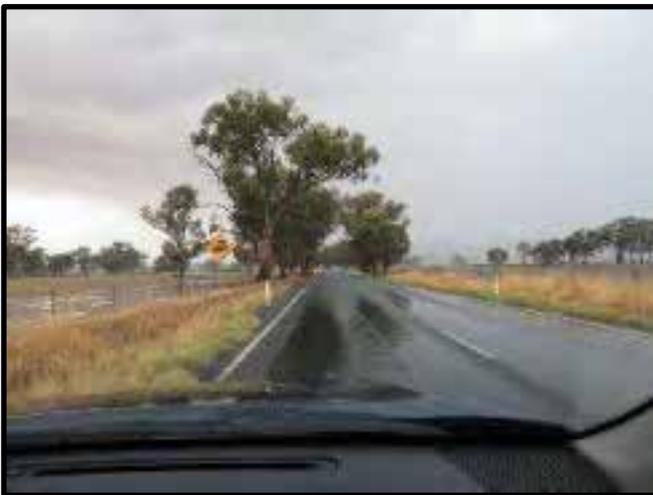
Figure 6 Benambra Road facing west approx. 3.7km from Olympic Highway

- The majority of Benambra Road is a sealed carriageway around 7.0 metres in width with one-lane in each direction (i.e. 2 x 3.5 metre wide traffic lanes)
- Approximately 3.3 kilometres of the road is an unsealed gravel road with a width of around 7.0 metres (i.e. 2 x 3.5 metre wide traffic lanes);
- Road is slippery when wet due to a thin layer of quarried material;
- Poor drainage along the road;
- No central median; and
- No posted speed limits.

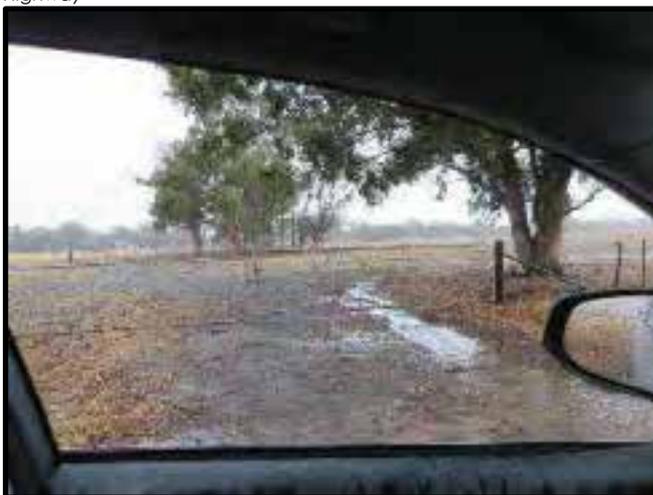
Figure 8 Benambra Road facing south farm access will not be used for construction

Figure 8 shows an existing access point which could be used to access the site and potentially cross from one side of the site to the other. Improvement to the gate and entry road would be required if this location is to be used for site access.

The proposed access points to the site are illustrated in **Figure 21**. These proposed access points for the site are located away from residential dwellings and to minimise the potential impact on local road operations. The main site access point for construction traffic would be from the sealed section of Benambra Road, around 2.6 kilometres west of Olympic Highway in the north eastern corner of the subject site. Existing site access (see **Figure 11**) would not be used for construction as it is considered too close to existing residential dwellings.

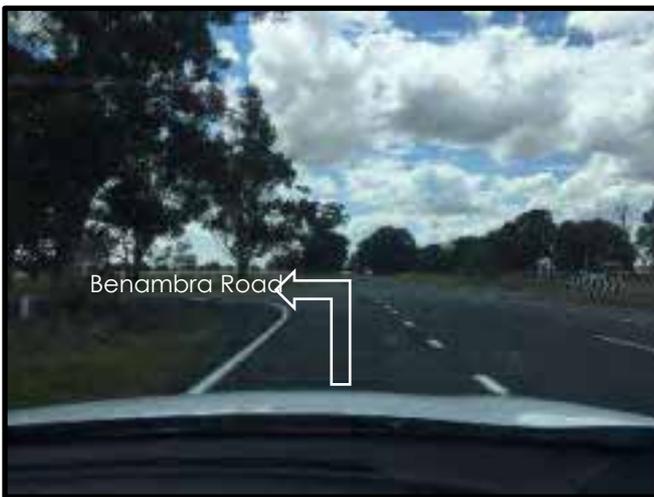
Figure 10 Olympic Highway facing north – left turn onto Benambra Road

- Sealed carriageway approximately 7.0 metres wide with one-lane in each direction (i.e. 2 x 3.5 metre wide traffic lanes);
- Several Turning and overtaking lanes;
- Posted speed limit of 100 km/h;
- No central median; and
- Priority controlled intersection throughout.

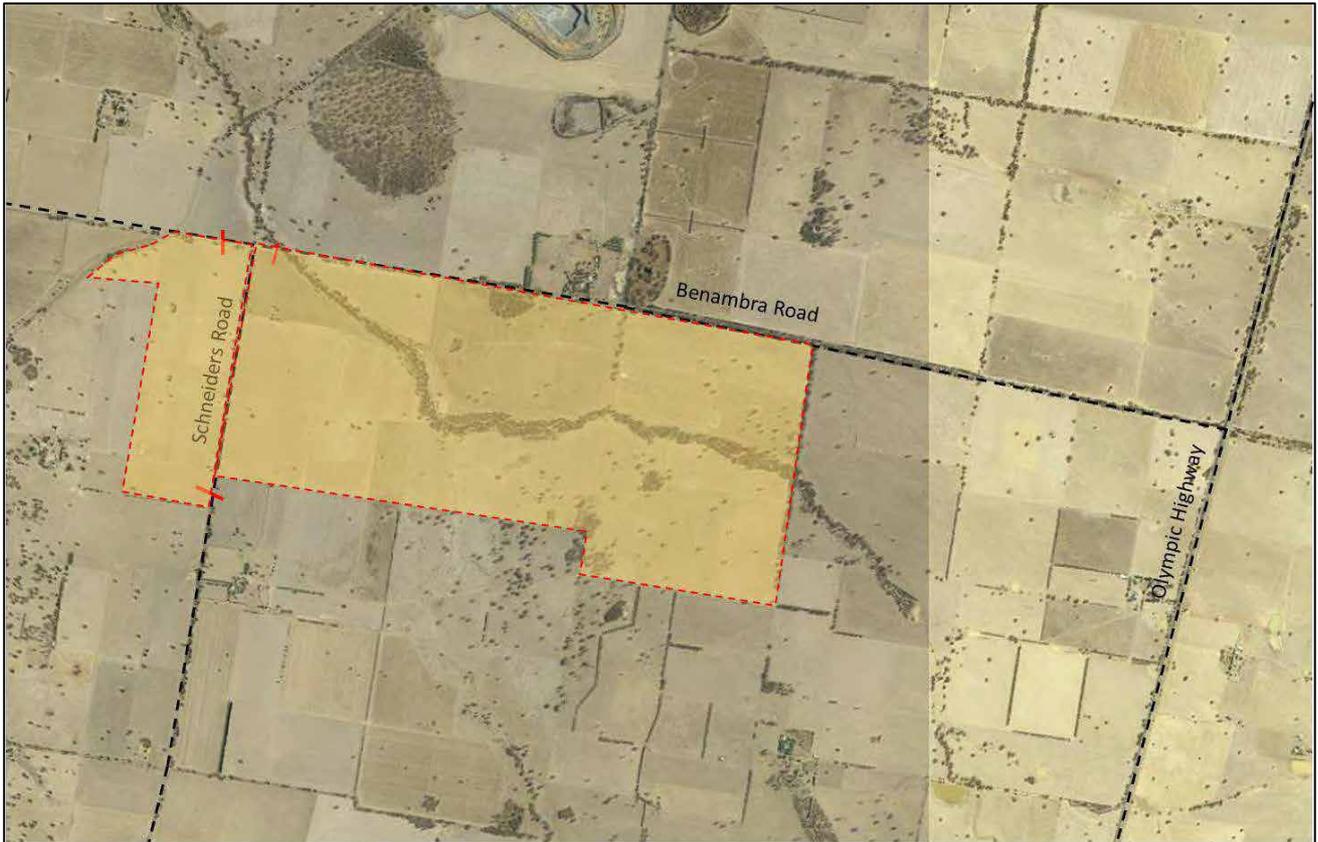
Figure 14 Traffic counter locations

To assist with the existing conditions and future utilisation assessments, traffic data was collected from Council for Schneiders Road and Benambra Road. Traffic counters were located along road corridors in close proximity to the site as illustrated by red lines in **Figure 17**. The key corridors included:

- Schneiders Road between Benambra Road and Rockville Road;
- Benambra Road 100 metres east of Schneiders Road; and
- Benambra Road 100 metres west of Schneiders Road.

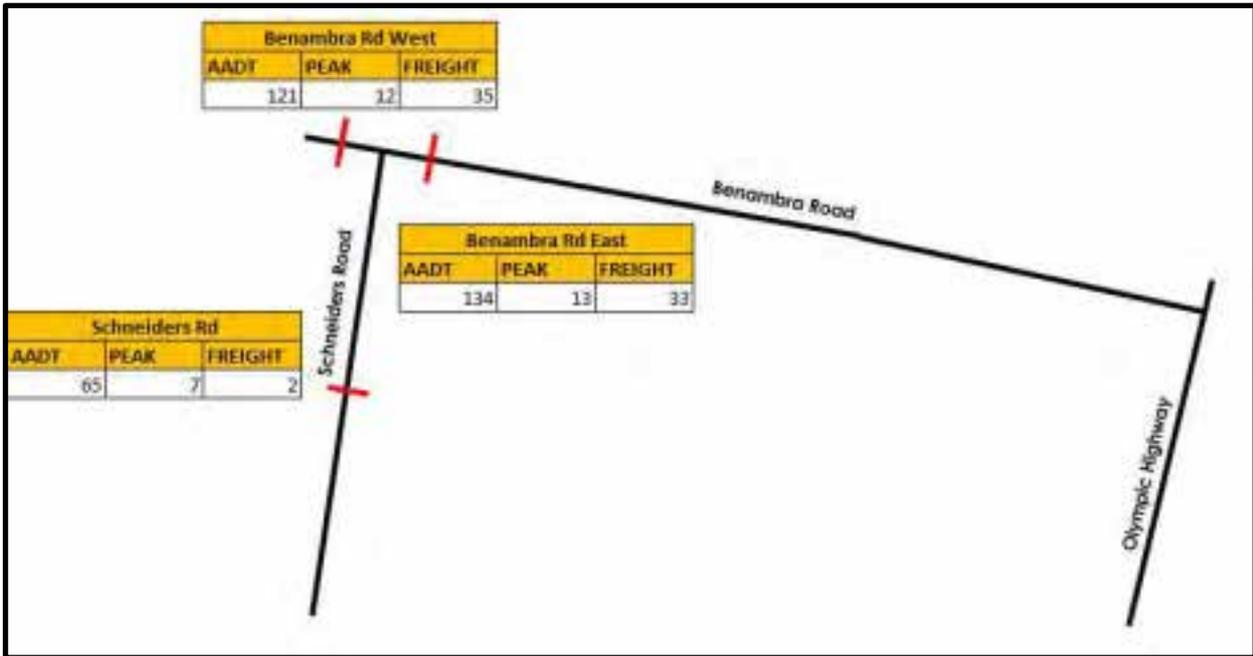
Figure 18 AM and PM peak traffic volumes at survey locations

Figure 18 illustrates the estimated average daily traffic (i.e. estimated AADT) volume, peak hour volume and daily freight volume based on the supplied traffic counts. The data suggests that the road network is operating well within its available capacity. However, more data will need to be gathered for all three roads to formulate a more accurate understanding of existing traffic conditions, specifically for the Olympic Highway.

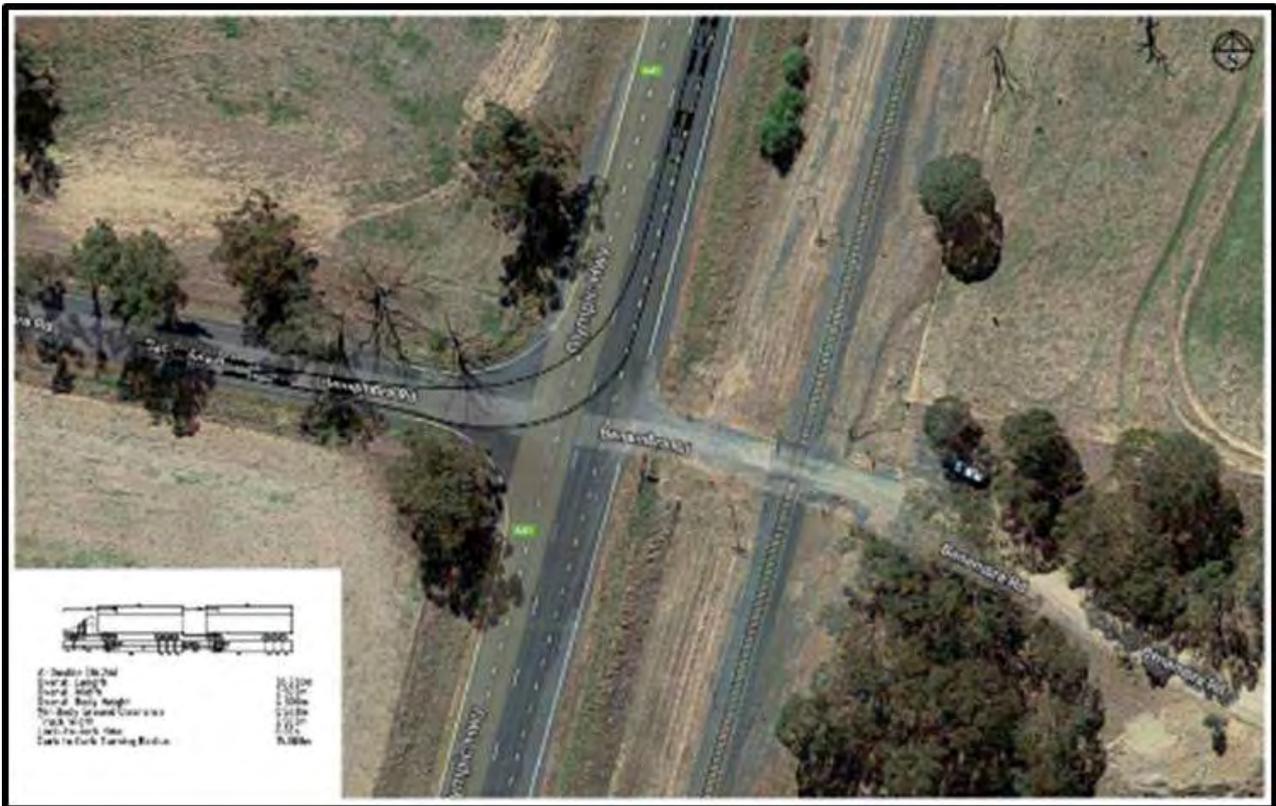
Figure 18 Swept path analysis turning right into Benambra Road

To assess the capability of the Olympic Highway/Benambra Road intersection to provide for large vehicles accessing the site, a swept path analysis was undertaken using Spiire's AUTOTURN programme. The swept path analysis assessed the ability for a 36 metre A-Double to negotiate the left and right turn into Benambra Road (see **Figure 18** and **Figure 19**).

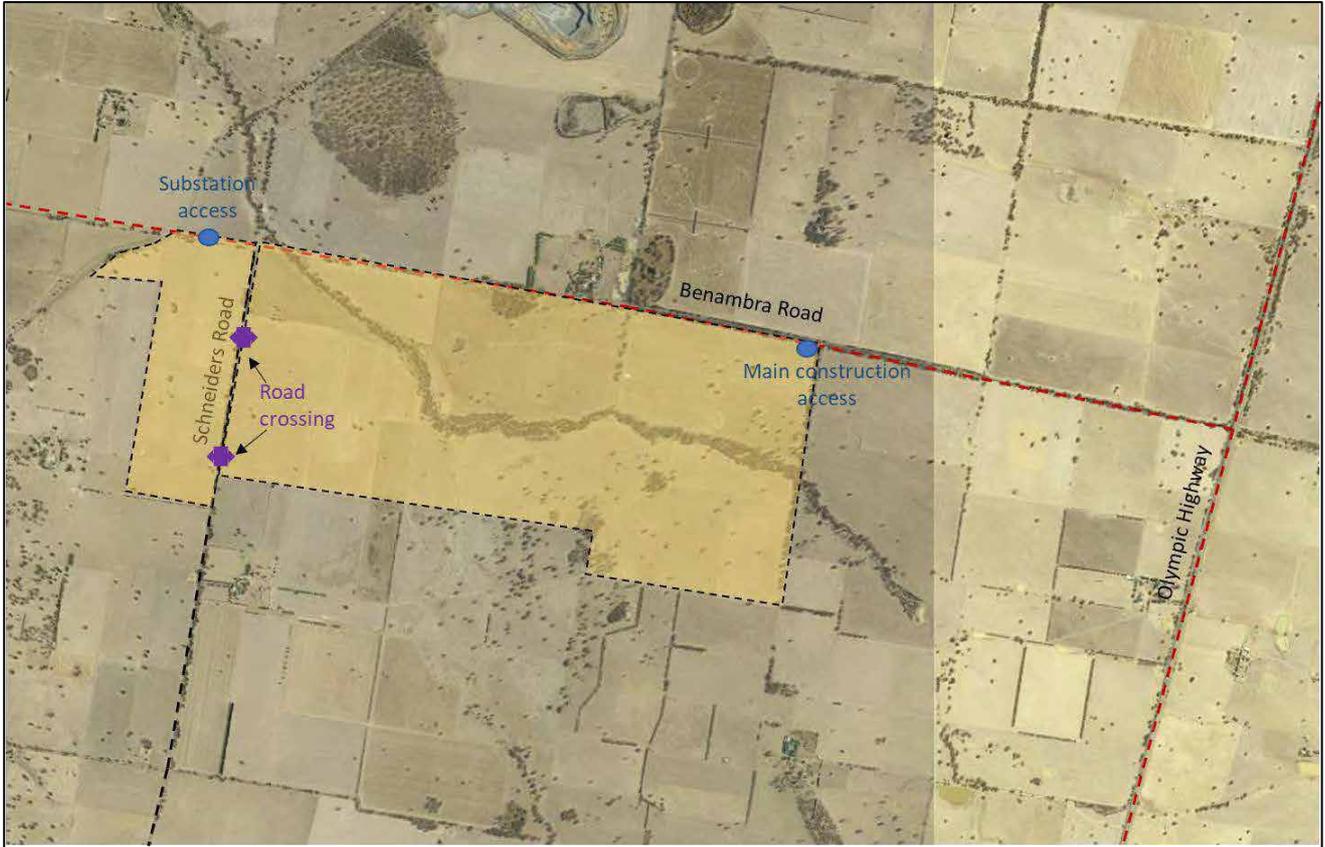
Figure 20 Planned site access

Due to the rural nature and existing land use of the subject site, there is no formal access point (i.e. no sealed or gravel access roads). The main access point would need to be constructed to provide for 36 metre long A-double vehicles and be sealed or at a minimum should be spread with crushed blue metal or gravel to reduce dust. Planned access points are illustrated in **Figure 20** and include:

Due to the generally flat nature of the site, there appears to be no issues that would affect the provision of access points anywhere along the surrounding road network. However, there are several existing access points that could be used as possible entry points to the site as shown below.

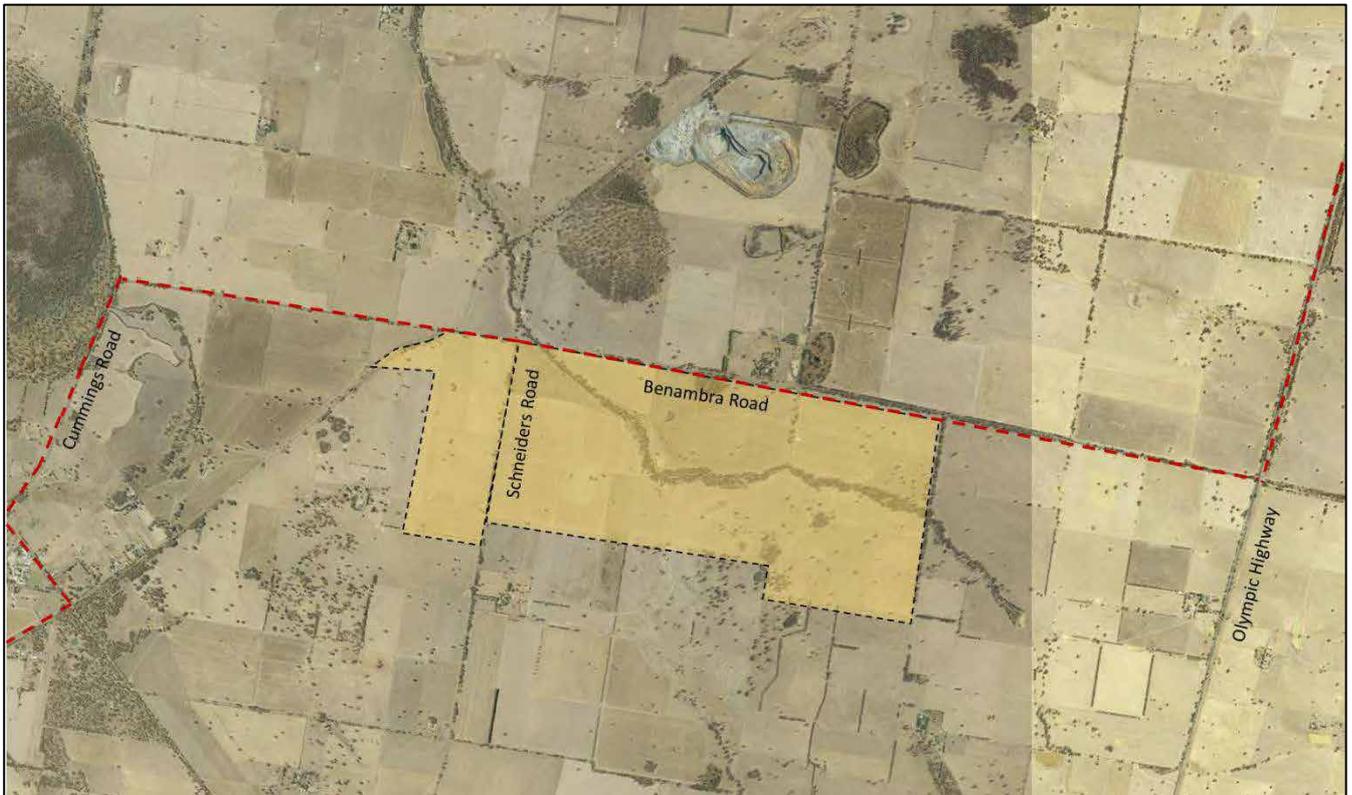
Figure 22 Future bus route

There are currently no regular public transport routes that service the proposed development site. Recently a new school bus service has been introduced to the area along the route shown in **Figure 22**. It is understood that two bus services use the route; one operates in the morning (at around 7:00-7:45am) and one operates in the afternoon (at around 3:30-4:00pm). There is a bus stop currently located at the end of Benambra Road.

The operation of the new bus route will have minimal impact upon the traffic assessment of the subject site. It is recommended that the future site traffic management plan note the operation of the bus route on Benambra Road and incorporate this into movement planning for construction phase activities and operational phase activities.

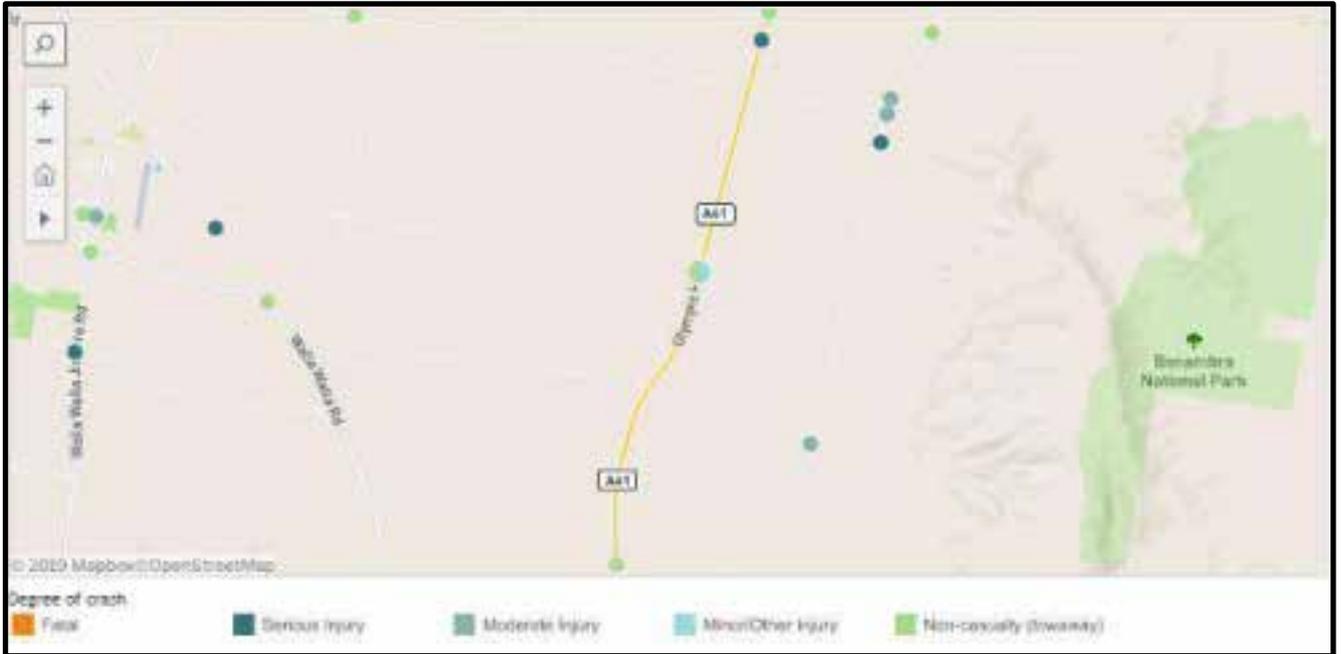
Figure 23 Map illustrating crash data (credit: NSW Government, 2016)

Figure 23 shows the location and severity of accidents on all roads in the vicinity of the subject site. It is evident that there has been a limited number of crashes.

Existing road crash data was sourced from the Transport for NSW road safety website, available from: http://roadsafety.transport.nsw.gov.au/statistics/interactivecrashstats/lga_stats.html?tblga=4 (Figure 23). A review of historic crash data (between 2012 and 2017) was undertaken focussing on the primary corridors to and from the proposed solar farm site at Walla Walla.

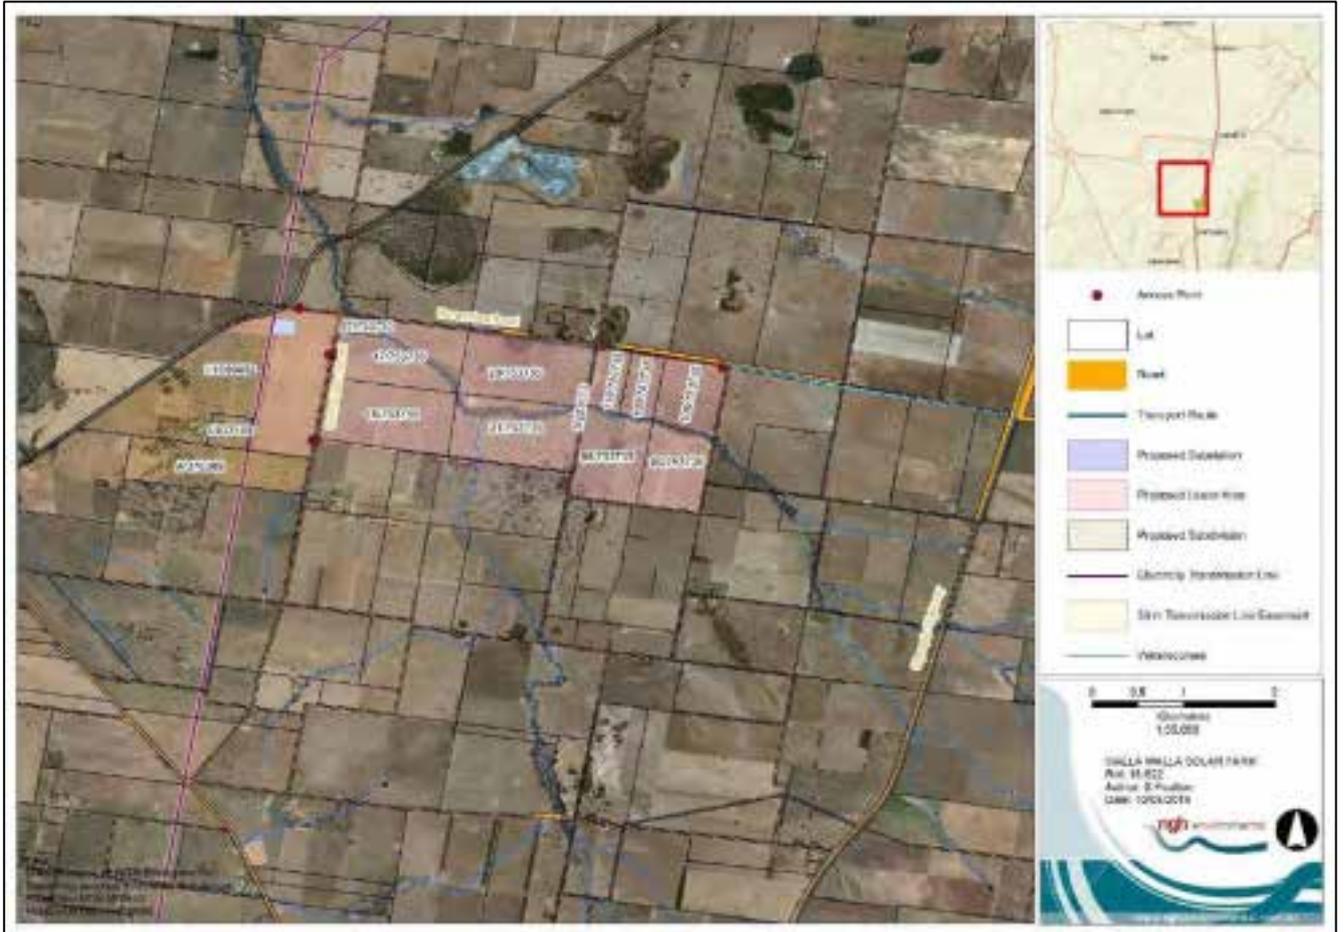
Figure 21 Proposed access points to the site (source: NGH)

Schneiders Road will not be used for site access but given that the site straddles Schneider Road, it is proposed to provide access crossing points from one side of the subject site to the other.

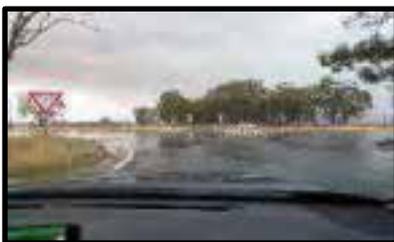
Figure 25 Benambra Road / Olympic Highway intersection

- Benambra Road and the Olympic Highway (see **Figure 25**)- a priority-controlled intersection which has a left turn storage lane for vehicles travelling northbound on the Olympic Highway turning into Benambra Road (see **section 2.1.3**);
- Benambra Road and Schneiders Road (see **Figure 26**) – a non-priority controlled intersection which provides other options for access into the site (see **section 2.1.1**); and
- Benambra Road and Cummings Road (see **Figure 27**) – a priority-controlled intersection which provides access to and from the town of Walla Walla.

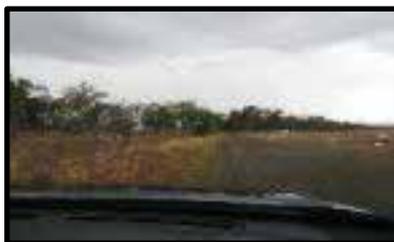
Figure 26 Benambra Road / Schneiders Road intersection

The recent site visit observed minimal traffic travelling through the Benambra Road / Schneiders Road intersection with most of that being travel between the east side of Benambra Road and the Olympic Highway. It is anticipated that the projected increase in traffic on the road network surrounding the site will have minimal impact on the intersection operations at any of these locations. Any possible delays that may occur would likely be limited to the movements turning onto the Olympic Highway and would only occur during the 16-20 month construction period. However, queues and delays are expected to be minor and only occur for short durations during the peak periods.

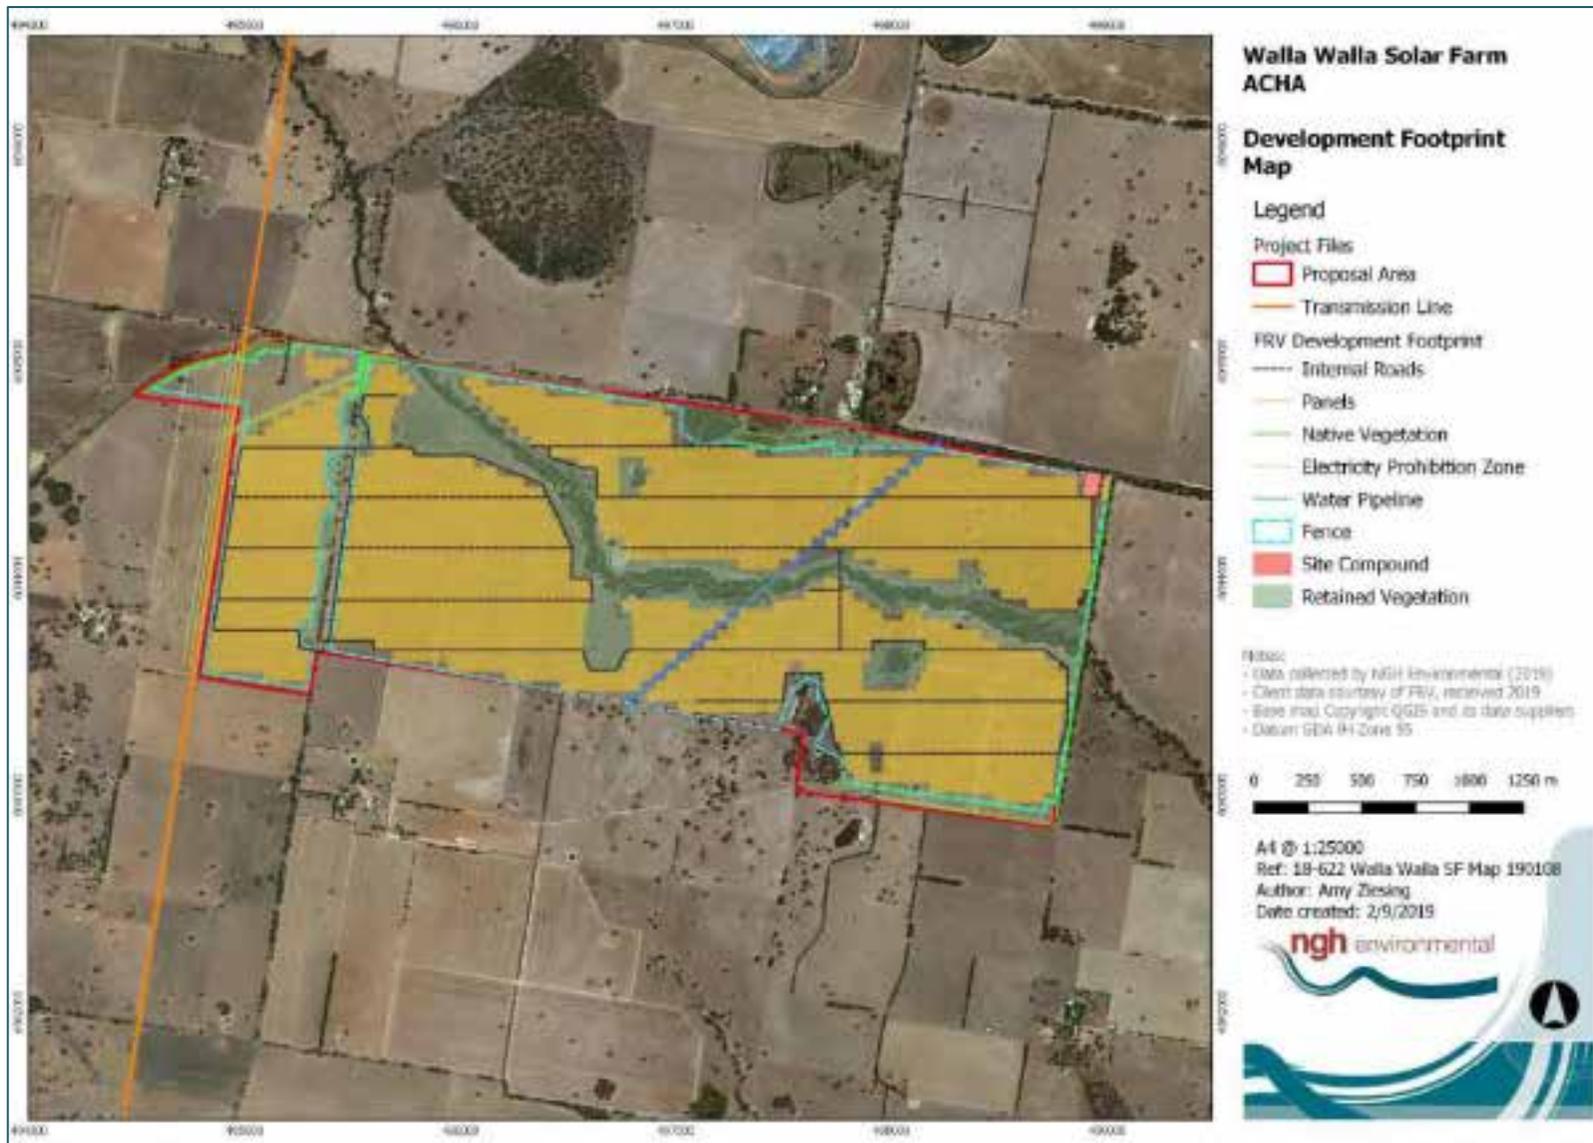
Figure 3 Proposed development footprint for the Walla Walla Solar Farm.

FRV Services Australia Pty Ltd (FRV) proposes to develop a solar farm approximately 4.3 km north east of the township of Walla Walla and 9.2 km south west of the town of Culcairn, NSW in the Greater Hume Local Government Area (LGA). The Walla Walla Solar Farm proposal area comprises of 605 hectares (ha) including Lots 16, 17, 20, 21, 87, 88, 89, 108, 109 and 118 DP753735, and Lot 22 DP1069452 (Figures 1 and 2). The proposal involves the construction of a ground-mounted photovoltaic solar array generating approximately 300 MegaWatt (MWac) of renewable energy. The proposed development footprint extends over approximately 493 ha (Figure 3).

The Walla Walla Solar Farm proposal area is in Greater Hume LGA approximately 4.3 km north east of the township of Walla Walla. The Walla Walla Solar Farm proposal area comprises of 605 ha on Lots 16, 17, 20, 21, 87, 88, 89, 108, 109 and 118 DP753735, and Lot 22 DP1069452. The proposed development footprint comprises of approximately 493 ha as shown in Figure 3.

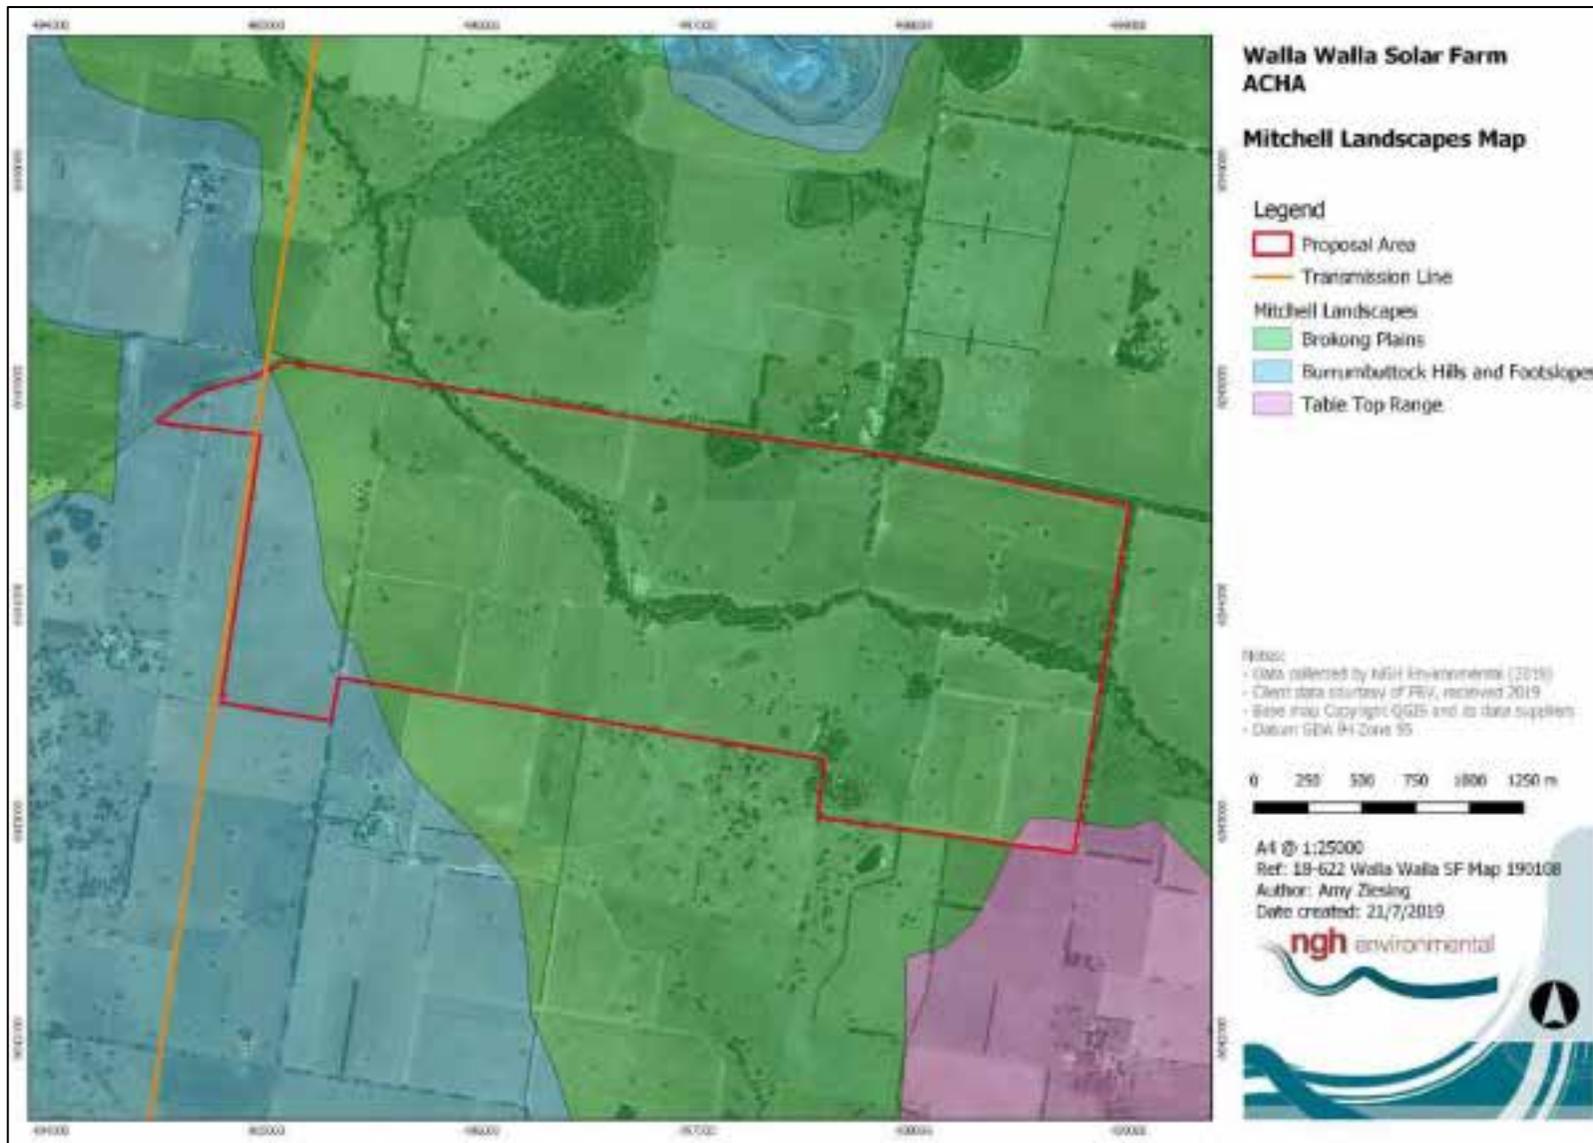
Figure 4 Mitchell Landscapes within the proposal area.

Further landscape mapping as part of the Mitchell landscapes system (2002) divides the proposal area into three differing landscape types (see Figure 4). These landscapes are the Brokong Plains (Bro), Burrumbuttock Hills and Footslopes (Bbk) and Table Top Range (Ttr) (descriptions of the Mitchell Landscapes are provided in Table 2 below). The Mitchell landscapes provide more specific landform, soil and vegetation profiles for these three landscape areas.

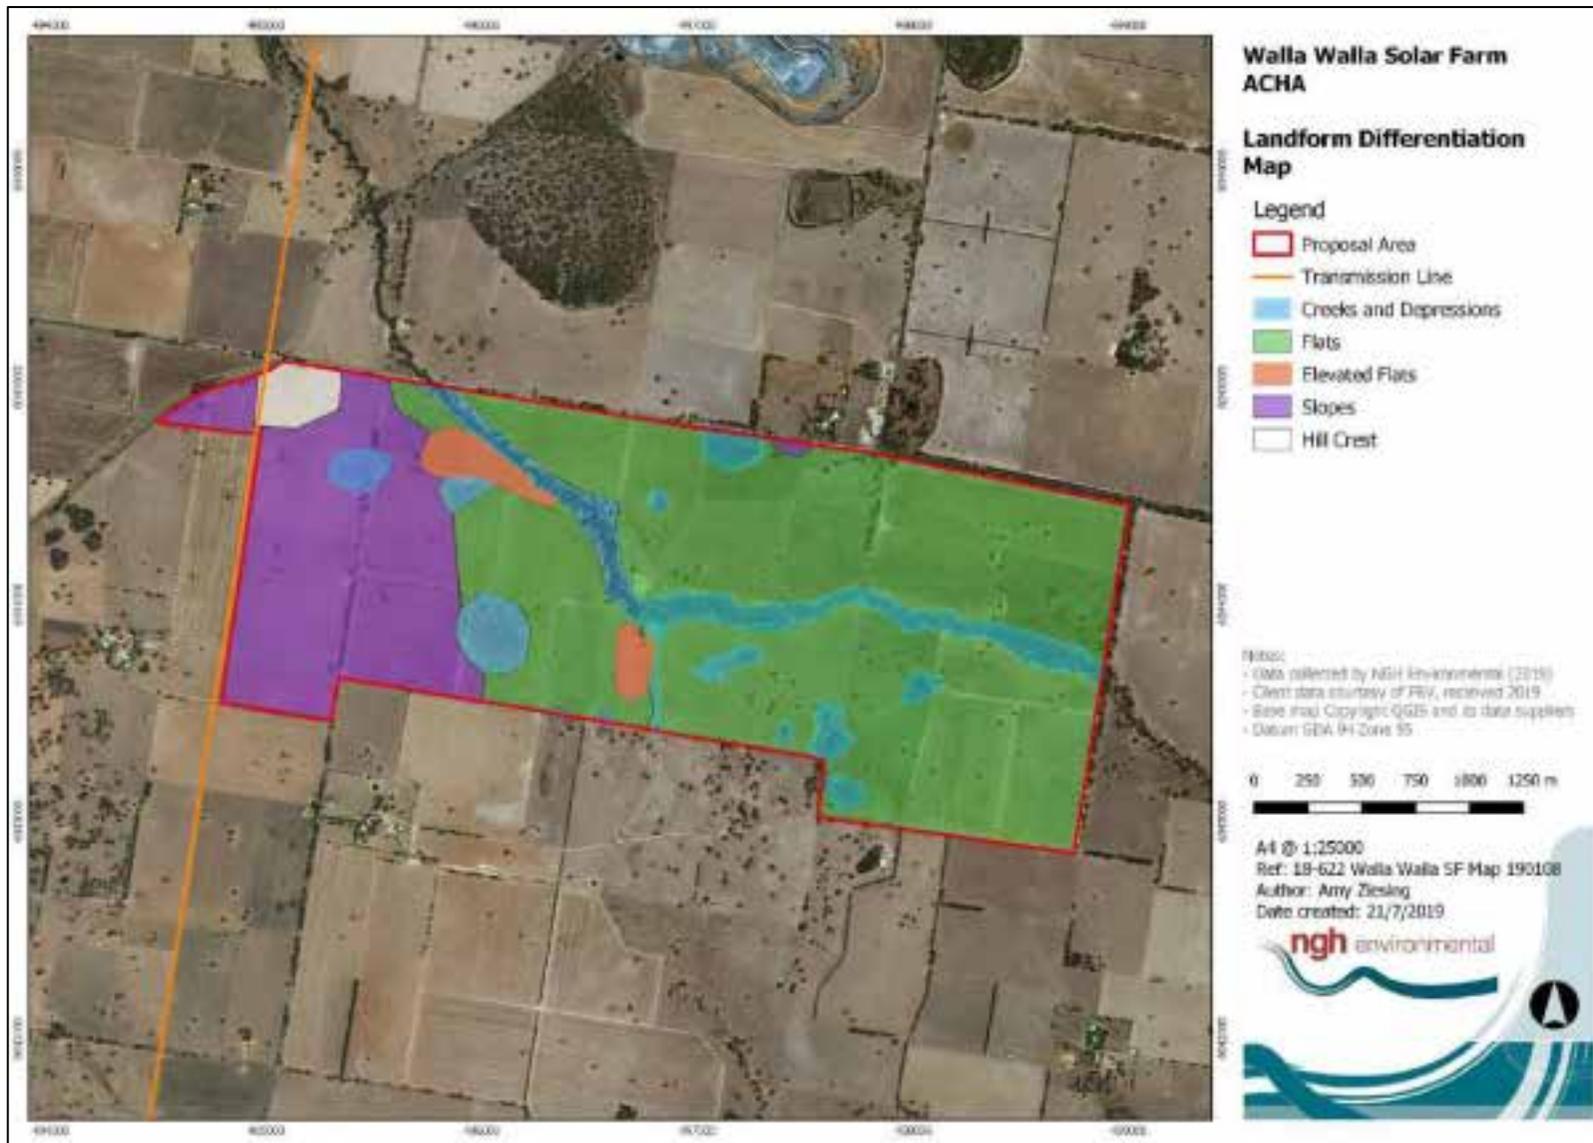
Figure 5 Landforms within the proposal area.

proposal area during field survey and from the review of detailed contour and DEM mapping. These five landforms are shown in Figure 5 and listed below.

- Creeks and depressions;
- Flats;
- Gradual slopes;
- Hill Crest; and
- Elevated flats.

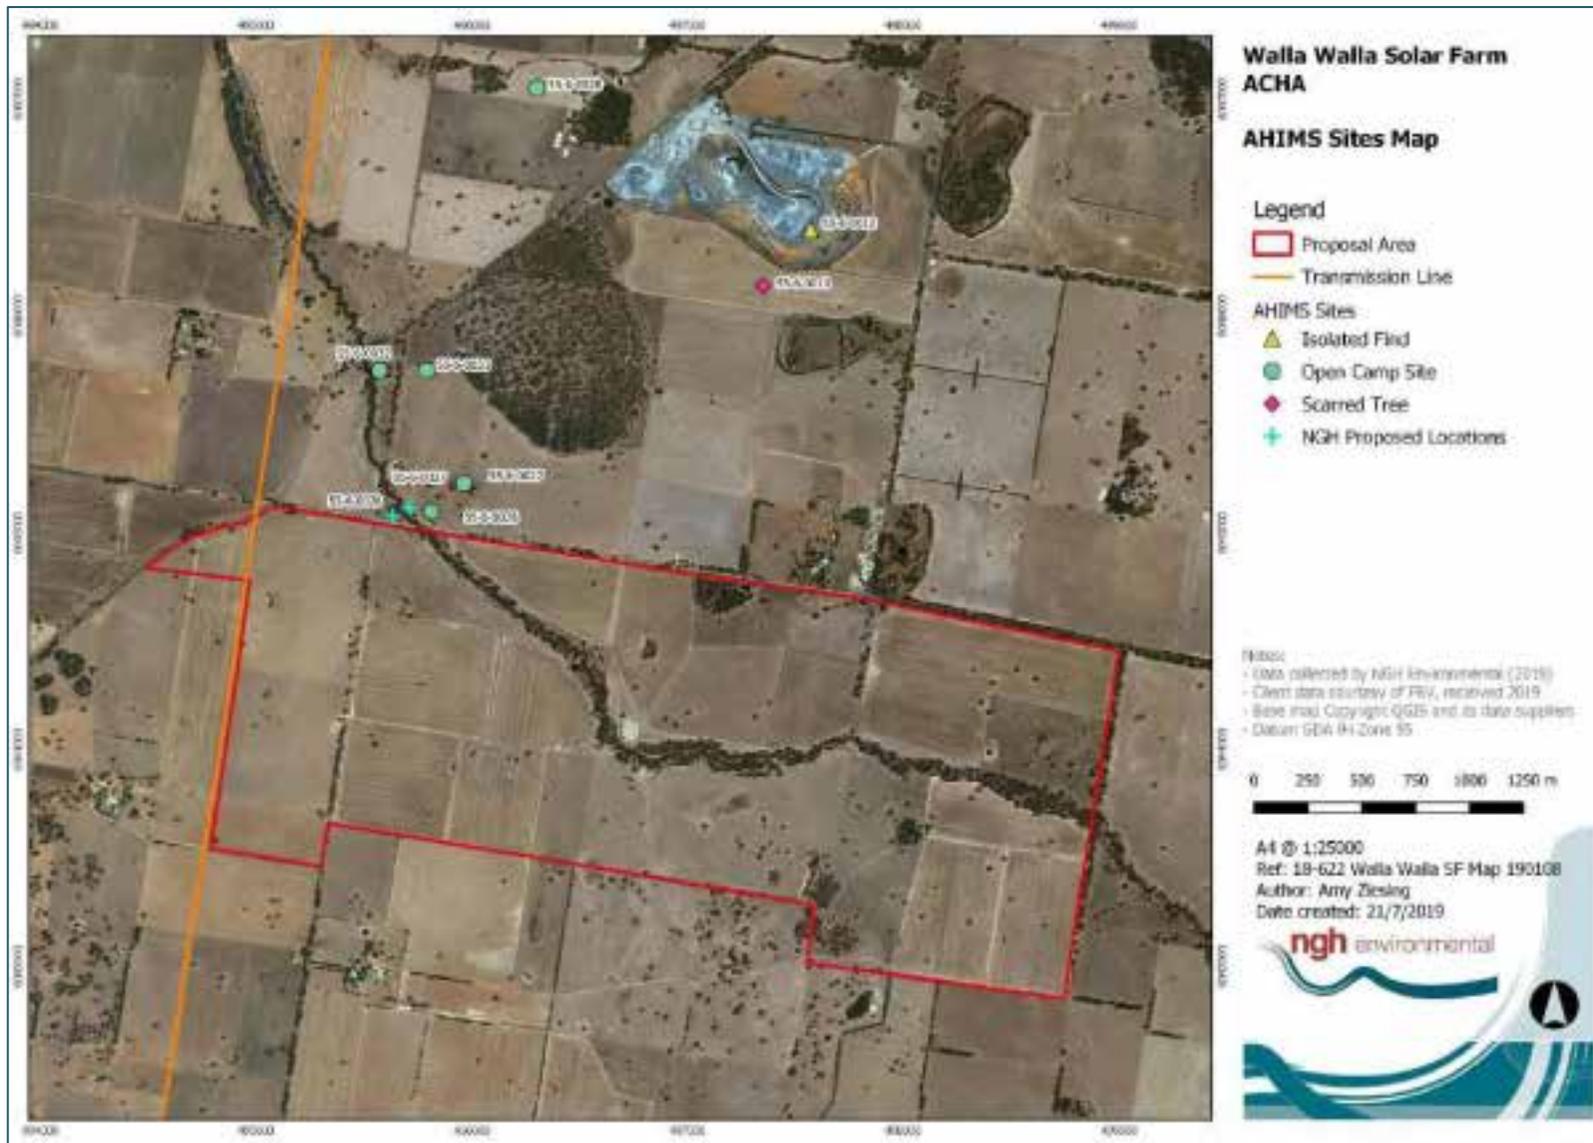
Figure 7 AHIMS Sites in the proposal area.

No registered sites lie within the Walla Walla Solar Farm proposal area. Two registered artefact scatters, or open campsites, are located according to their GPS coordinates between 60-200 m north of the proposal area along Back Creek (AHIMS# 55-6-0026 and #55-6-0027). However, further investigation of the archaeological reports associated with the sites AHIMS# 55-6-0026 and #55-6-0027 indicate that historically the GPS coordinate data is inaccurate and that AHIMS# 55-6-0026 is fact located on the southern bank of Back Creek directly north of Benambra Road and AHIMS# 55-6-0027 is located just the other side of AHIMS# 55-6-0026 on the northern bank of Back Creek, north of Benambra Road. While both sites are located outside the project area the proximity of the sites to the project area is in reality is approximately 60- 100 m north of the northern boundary of the project area as shown in Figure 7.

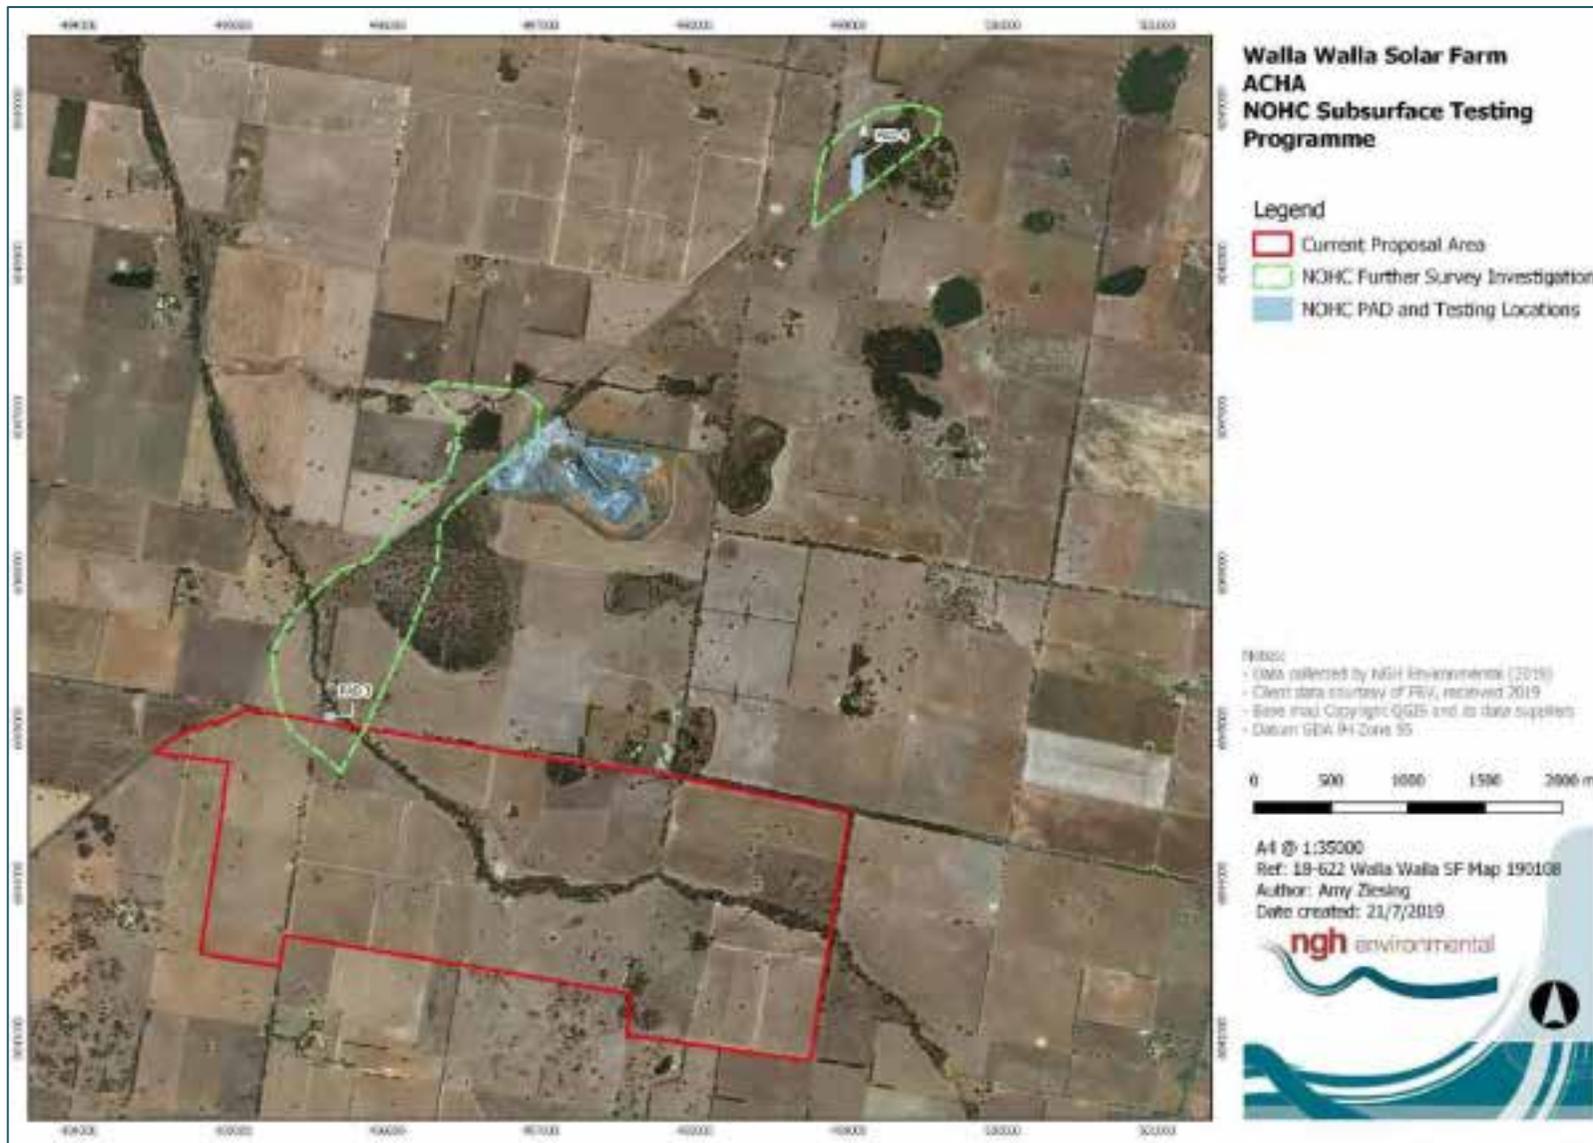
Figure 9 NOHC Subsurface Testing Program PAD and Testing Locations.

In 1998 Officer, Navin and Kamminga undertook a subsurface testing program for the proposed Wodonga to Wagga Wagga Natural Gas pipeline. The surveys, as noted above, identified a total of 39 sites, four isolated finds and eight areas of potential archaeological deposit (PAD). Four sites and seven PADs were unable to be avoided by the proposed development and the PAD to be impacted were consequently subject to further investigation in the form of a subsurface testing program (Figure 9). PAD 3, which is located to the immediate north of the current Walla Walla Solar Farm proposal area, was one of the PADs investigated during the subsurface testing program. Figure 9 below shows the areas identified for further survey in the initial 1995 survey in close proximity to the current assessment area and the refined PAD 3 and PAD 4 areas following the 1996 additional survey. The test pit locations excavated at PAD 3 (now site AHIMS# 55-6-0027) are shown in Figure 10 below. A summary of finds from the subsurface testing program undertaken at PAD 3 and PAD 4 is shown in Table 8.
